# Risky Roads 2021 survey results

Report – February 2022

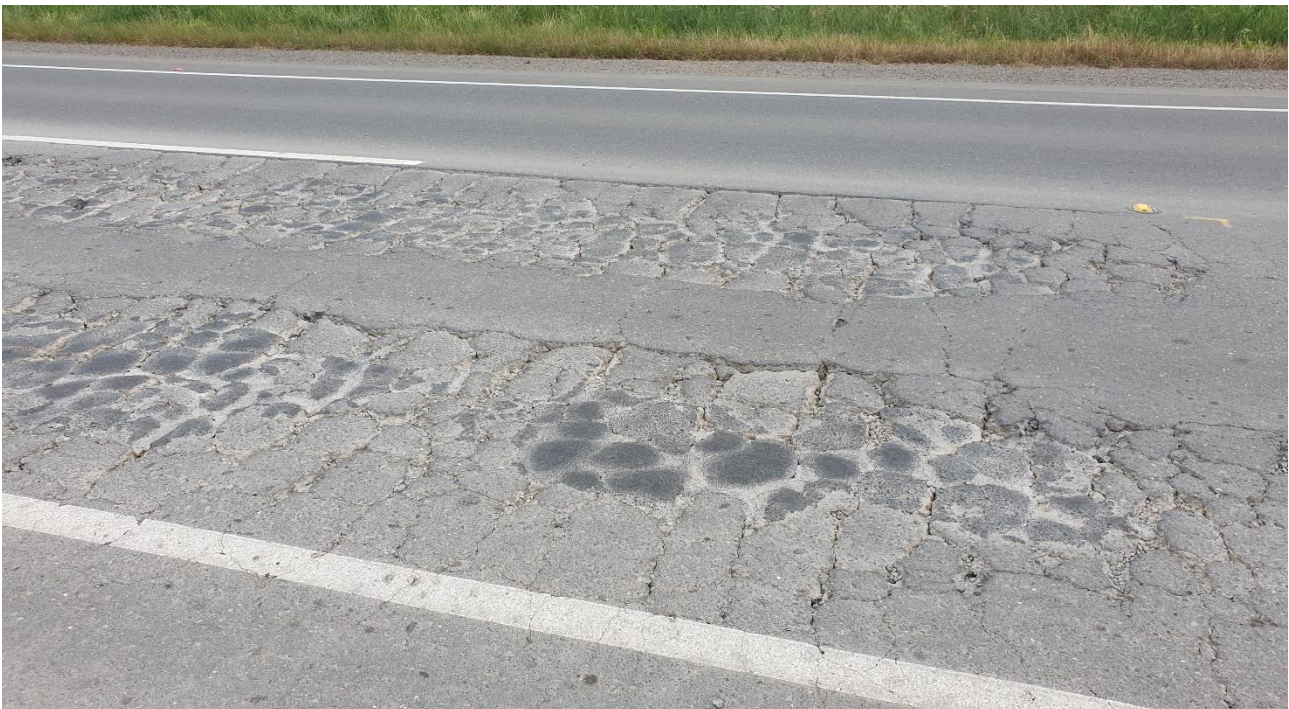
"The road is potholed, it is crumbling through to the base bed, when it rains mud comes up through the cracking, it rides like a roller coaster as the under bed has shifted and collapsed. It is the Main Road to the Fleurieu Tourist areas, and Kangaroo Island."

"Drivers drive all over the lanes to avoid the cracking/potholes."

Figure 8: Major pavement failures on Main South Road between Aldinga and Sellicks Beach in November 2020

"Rebuild from base up. The road needs total replacement. That is all. It has been promised since before the last State Election, and nothing, not one thing, has been done to improve the road since."

"Properly repair the road. It seems that due to plans to upgrade and duplicate Main South Road, upkeep has been minimal and full repairs are not being undertaken. The potholes that have been 'repaired' are just being filled with bitumen, which washes out as soon as there is any precipitation, causing more debris to be lying on the road."

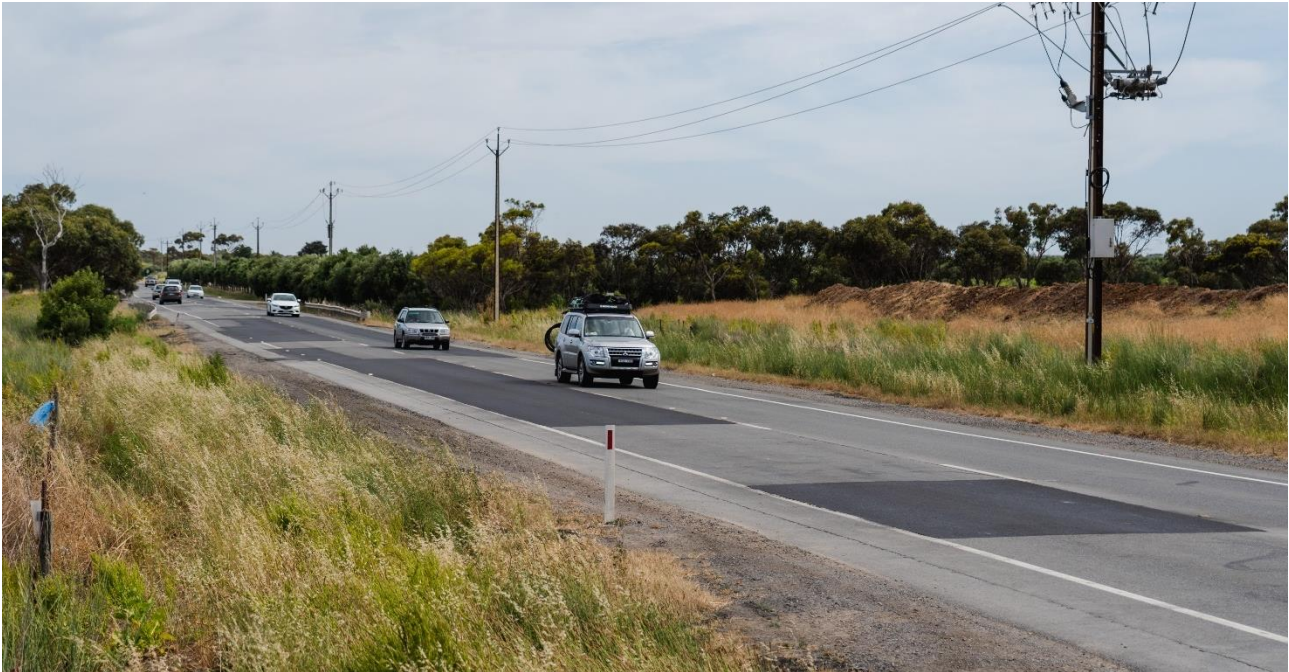
In late November 2021, whilst the survey was still open for responses, a series of short-term repairs were made along this section of Main South Road, which addressed the most significant failures in the road surface. This will improve safety and comfort for road users until the major upgrade commences.

Figure 9: Most failures were repaired in late November, whilst the Risky Roads survey was still open

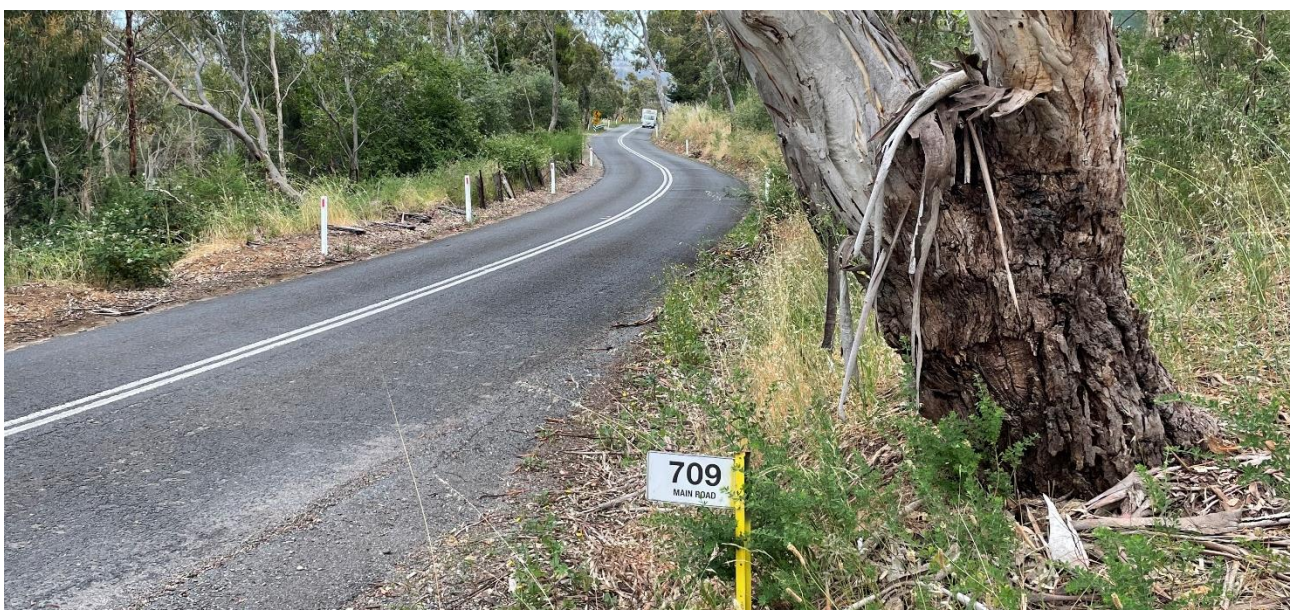
Figure 12: Main Road between Black Road and Oakridge Road is narrow and windy with unforgiving roadsides

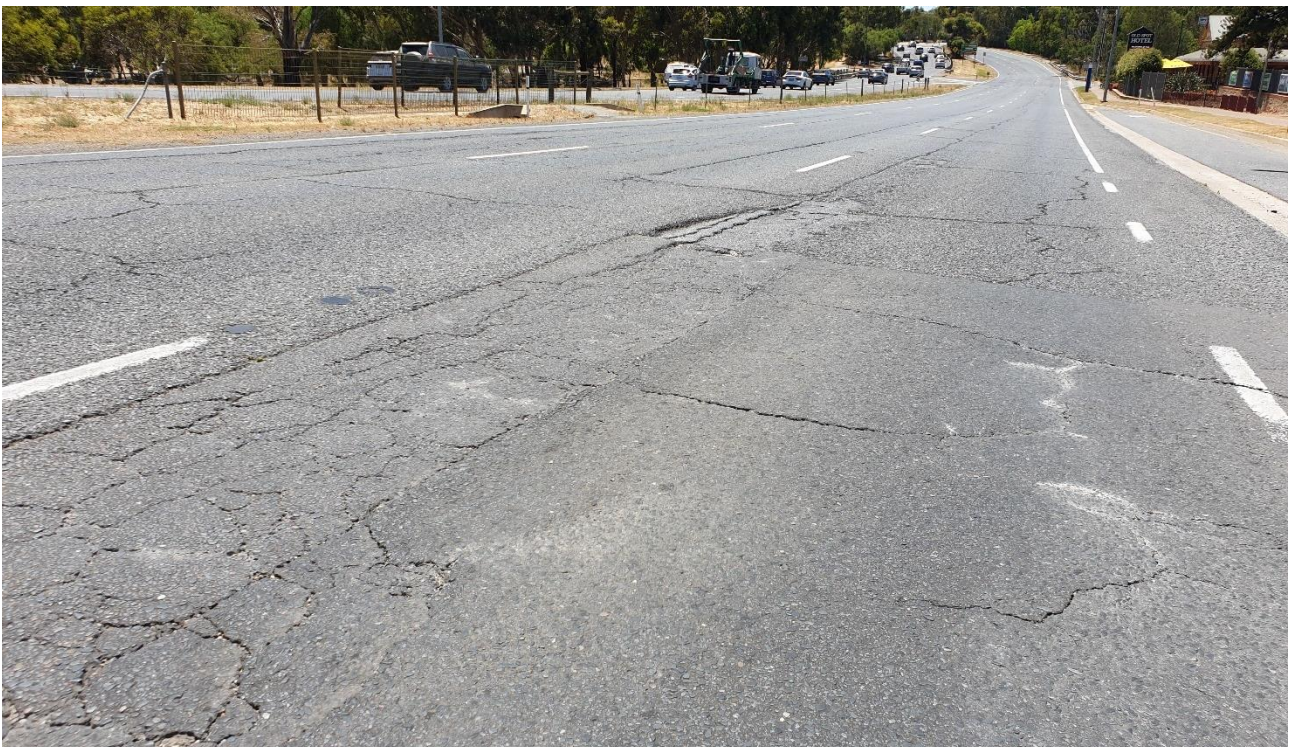
Figure 16: Deteriorating surface of Main North Road in Hillbank

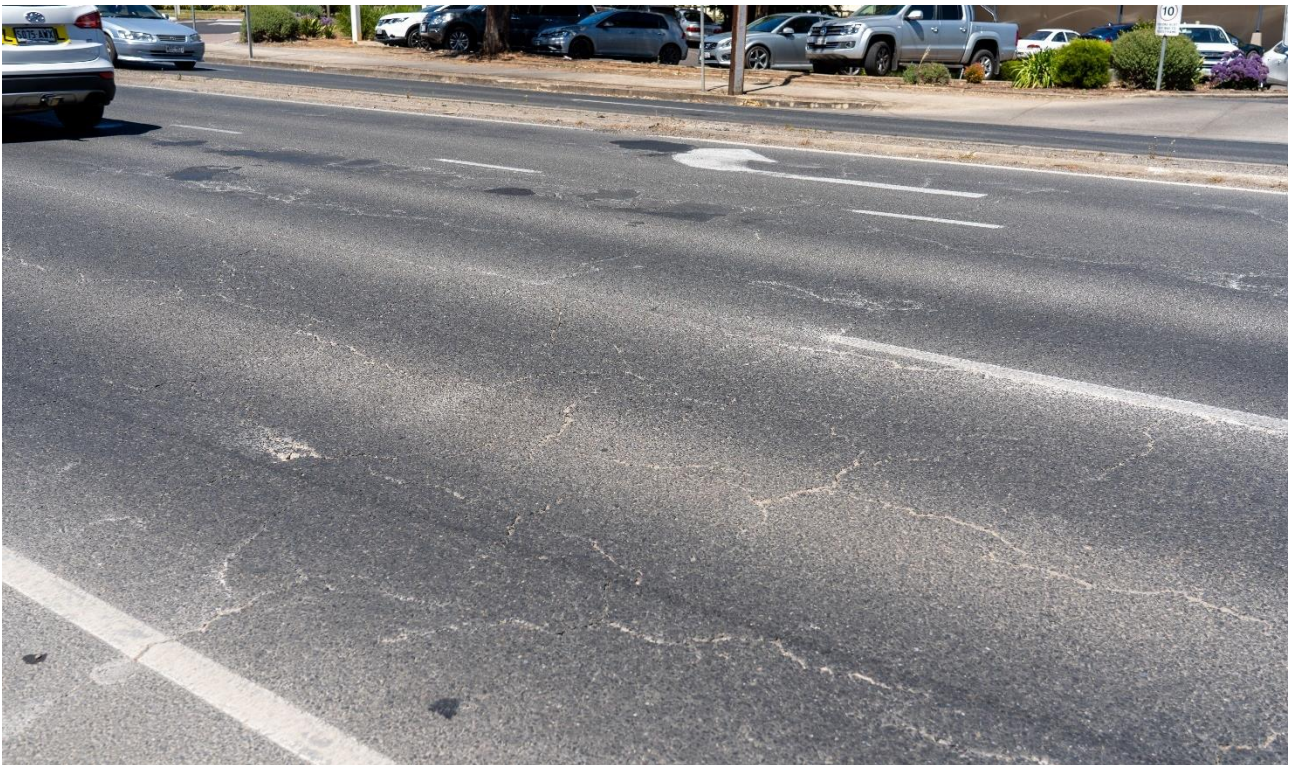
Figure 19: Cracking, ruts and potholes present on Glynburn Road near Firle Plaza

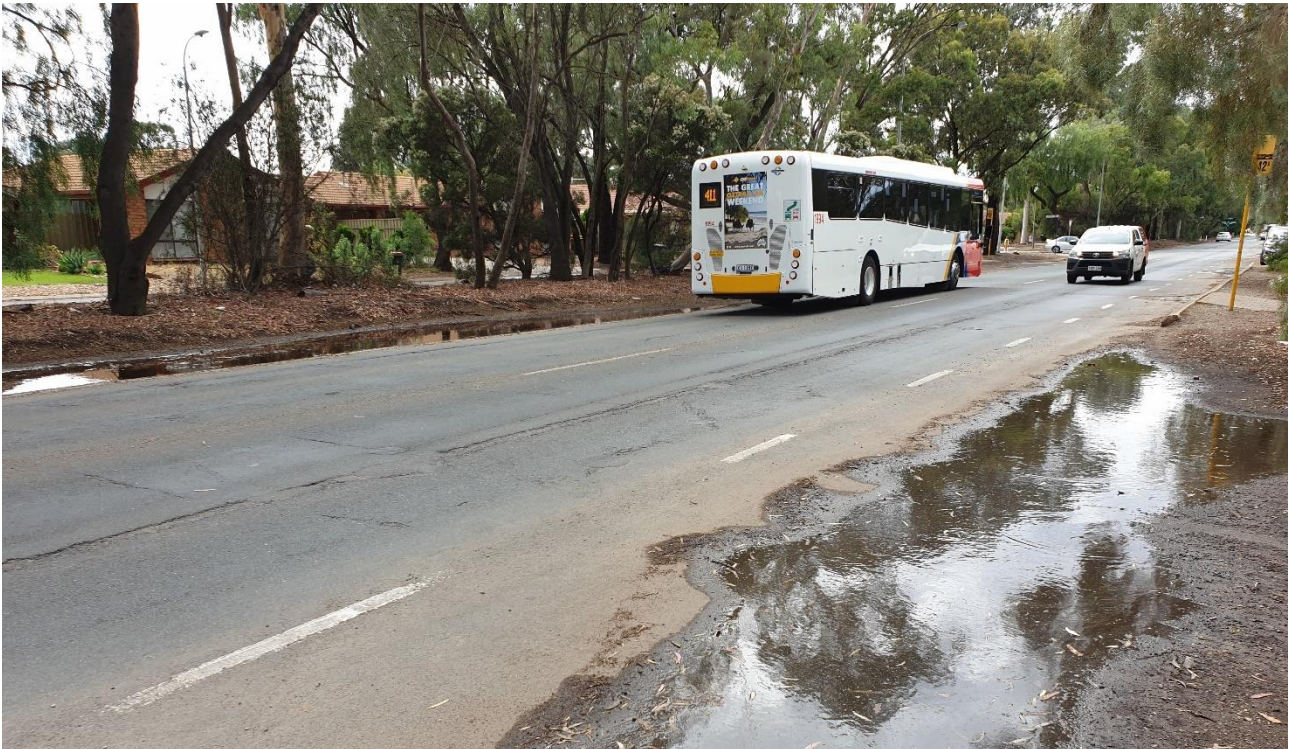
Figure 22: Poor drainage and deteriorated road surface on Kings Road

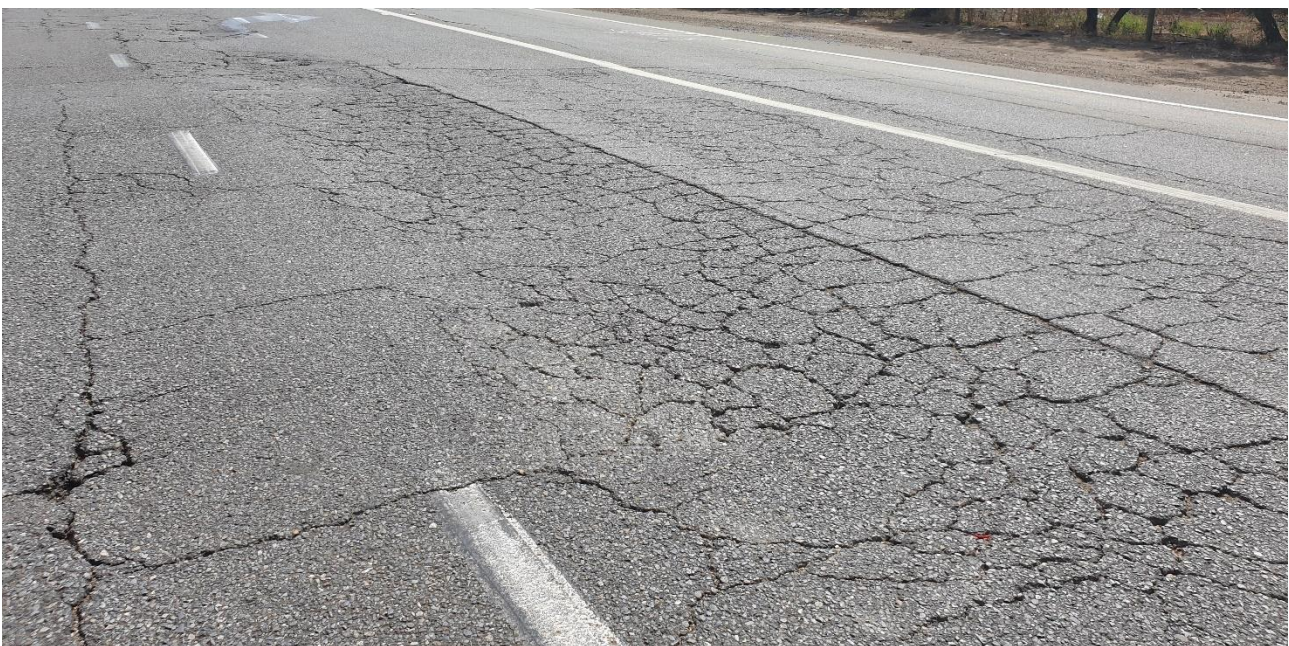
Figure 30: Cracks and rutting on Heaslip Road

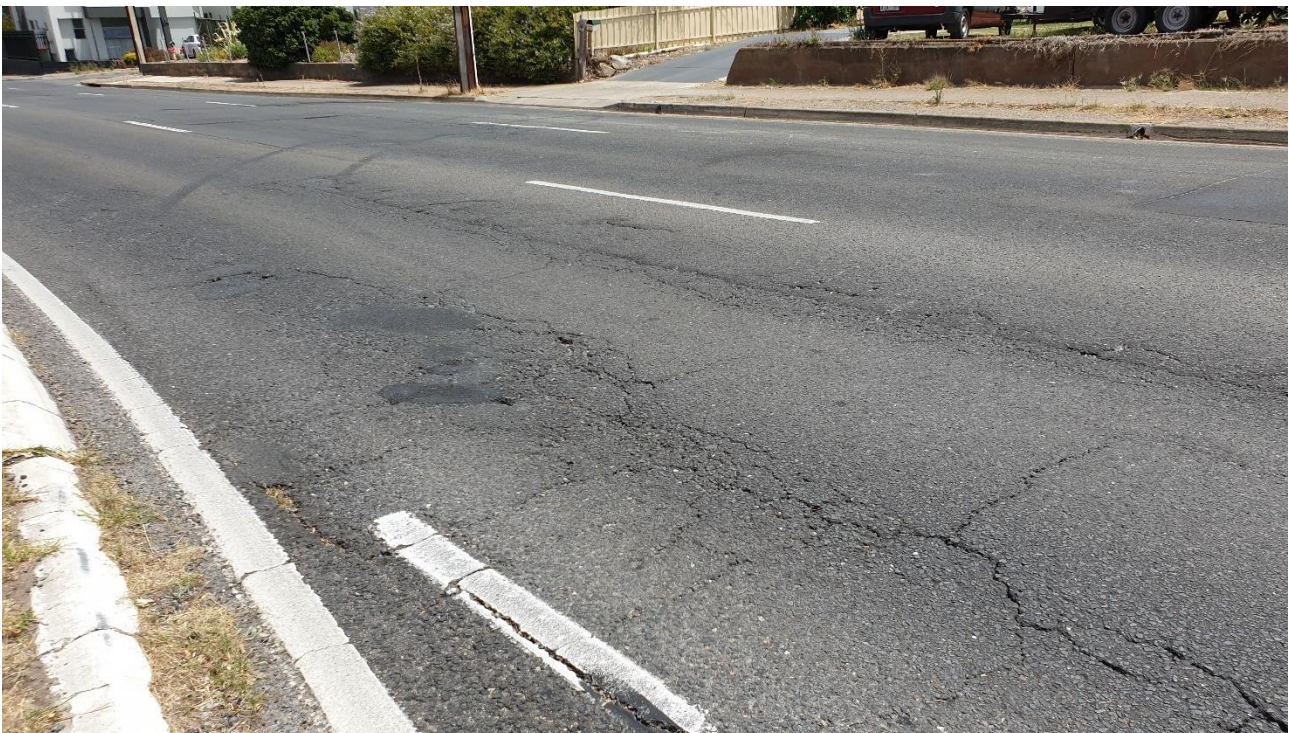
Figure 33: Deteriorated pavement between Golden Grove Road and Hancock Road

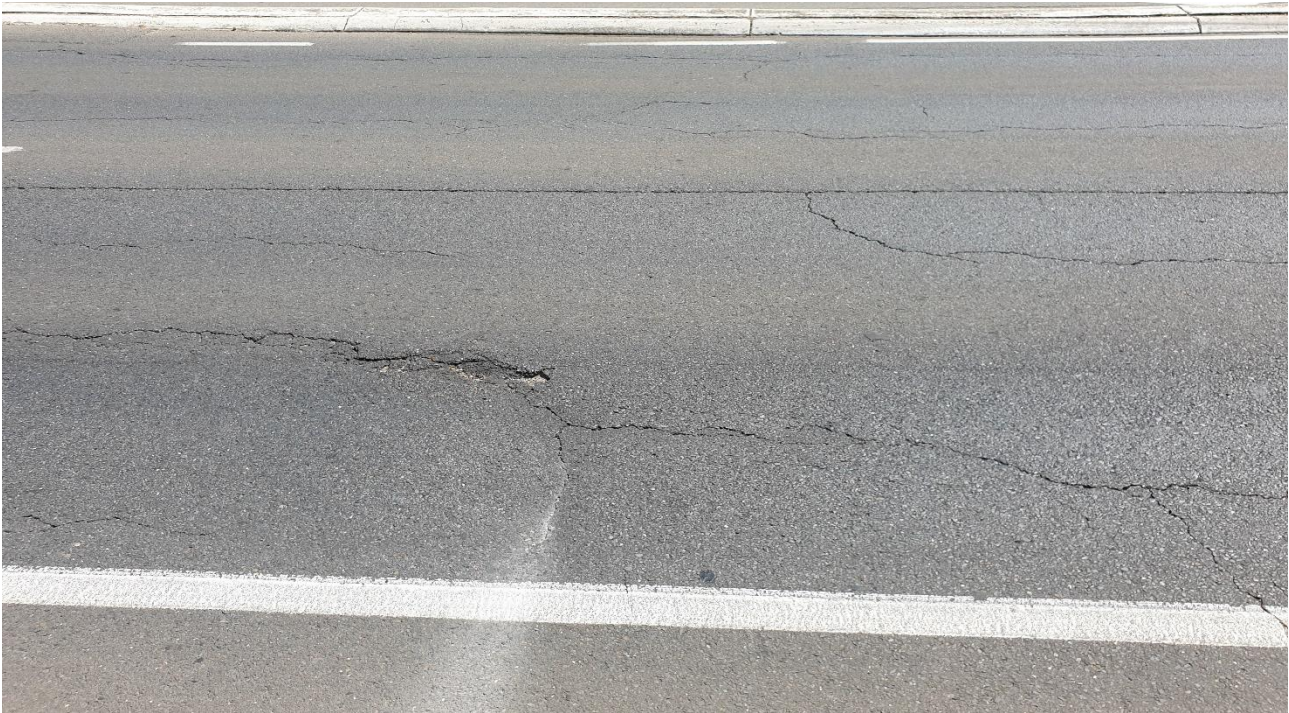
Figure 36: Cracks and a pothole forming on Grand Junction Road in Northgate

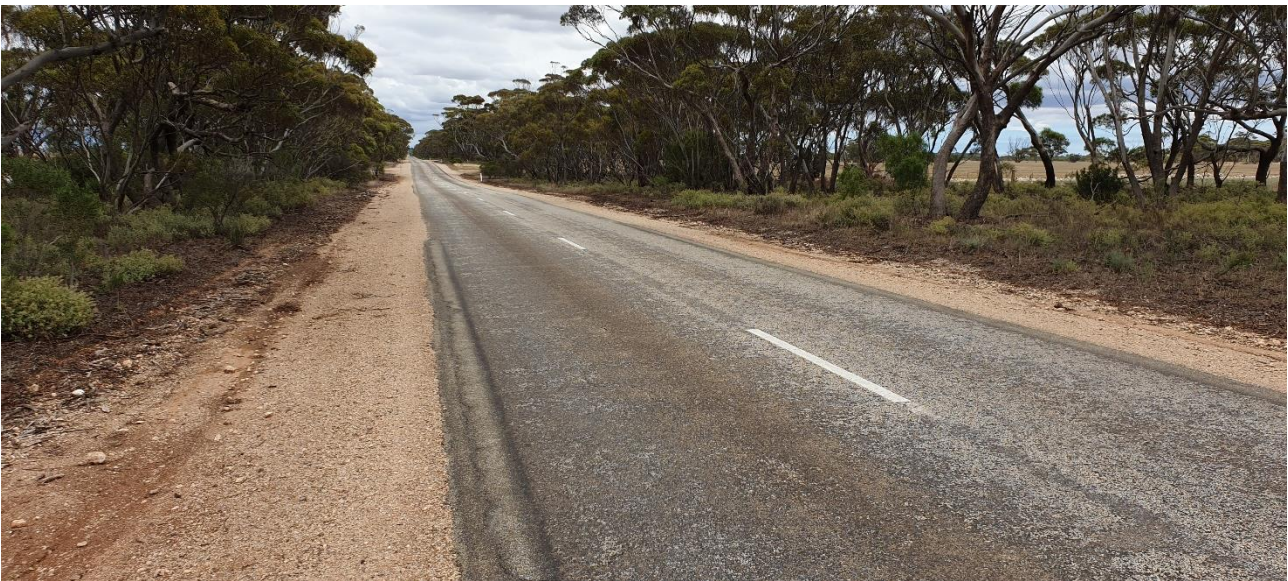
Figure 45: Upper Yorke Road is very narrow with an unforgiving roadside between Kulpara and Arthurton

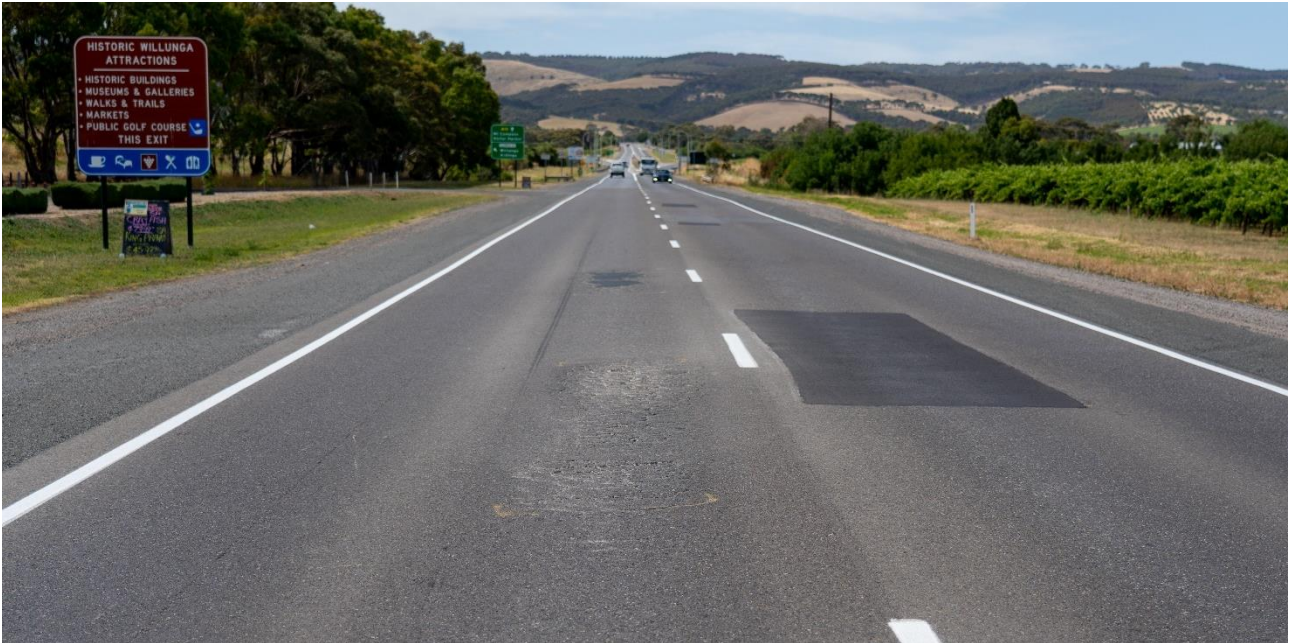
Figure 46: Sections of Victor Harbor Road between McLaren and Willunga are in poor condition

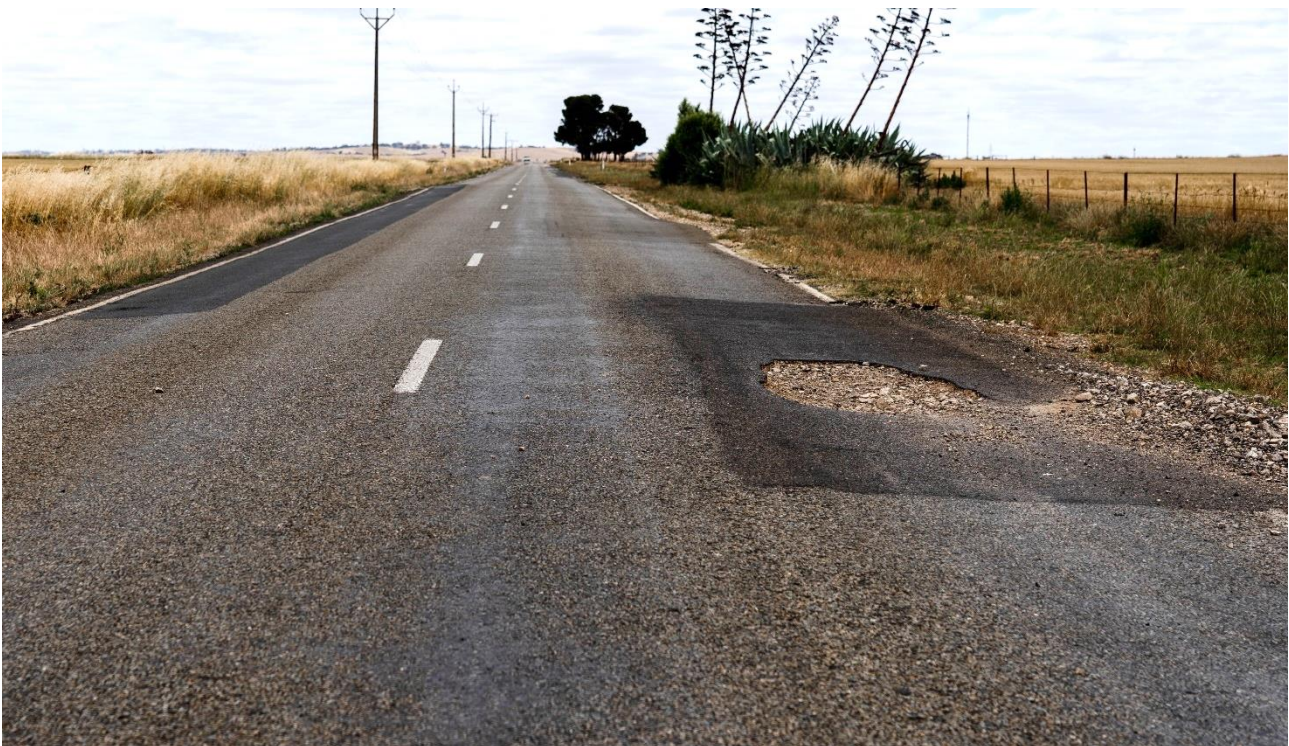
Figure 51: Previous minor repairs have not held up well along Owen Road

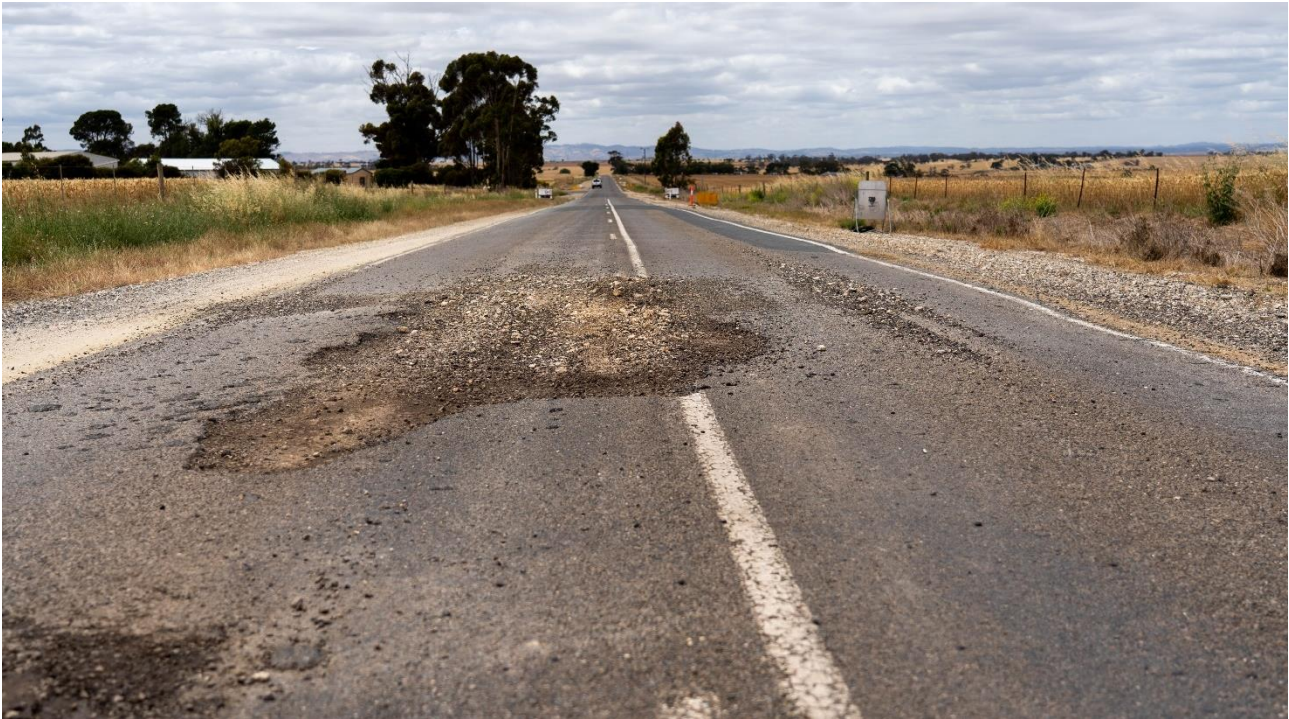
Figure 52: Major pavement failures such as the one pictured above (December 2021) appear regularly on Owen Road

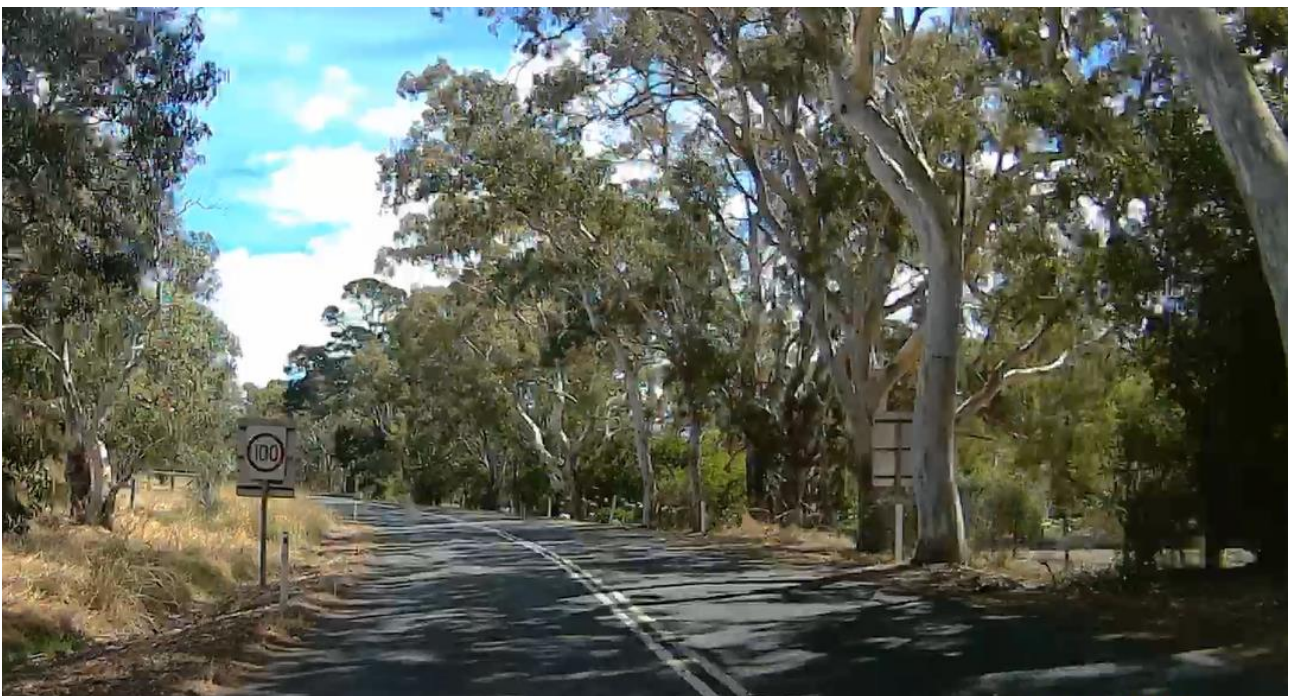
Figure 55: Inman Valley Road is narrow with a high speed limit and unforgiving roadsides.

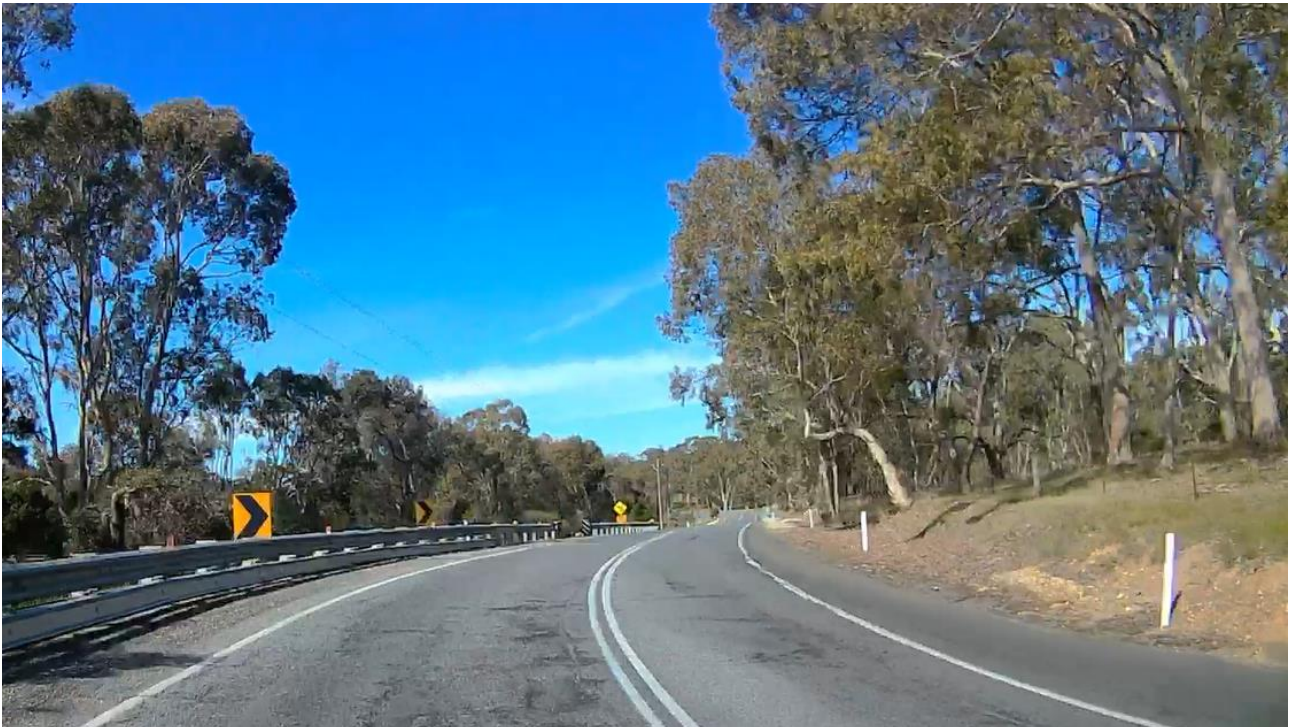
Figure 61: Parts of Torrens Valley Road are in poor condition, which is worse around curves

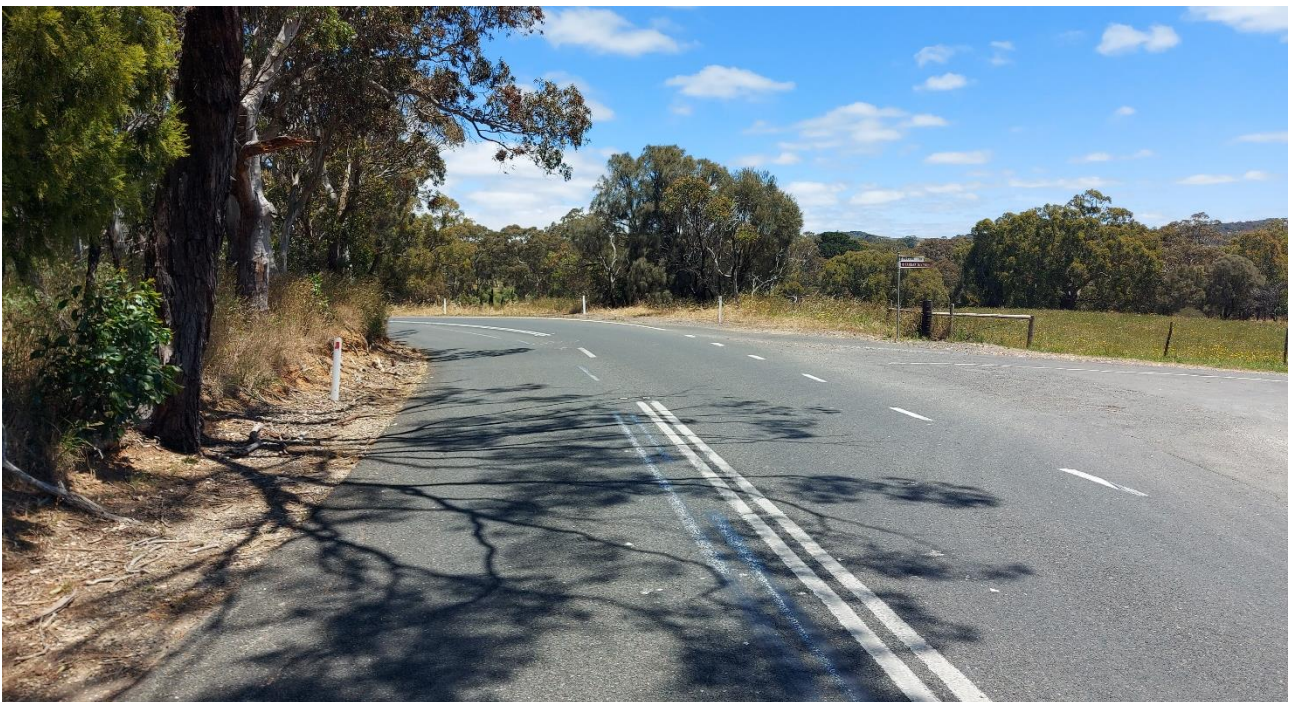
Figure 83: Sight distance is extremely poor when turning right from Strathalbyn Road onto Whites Road

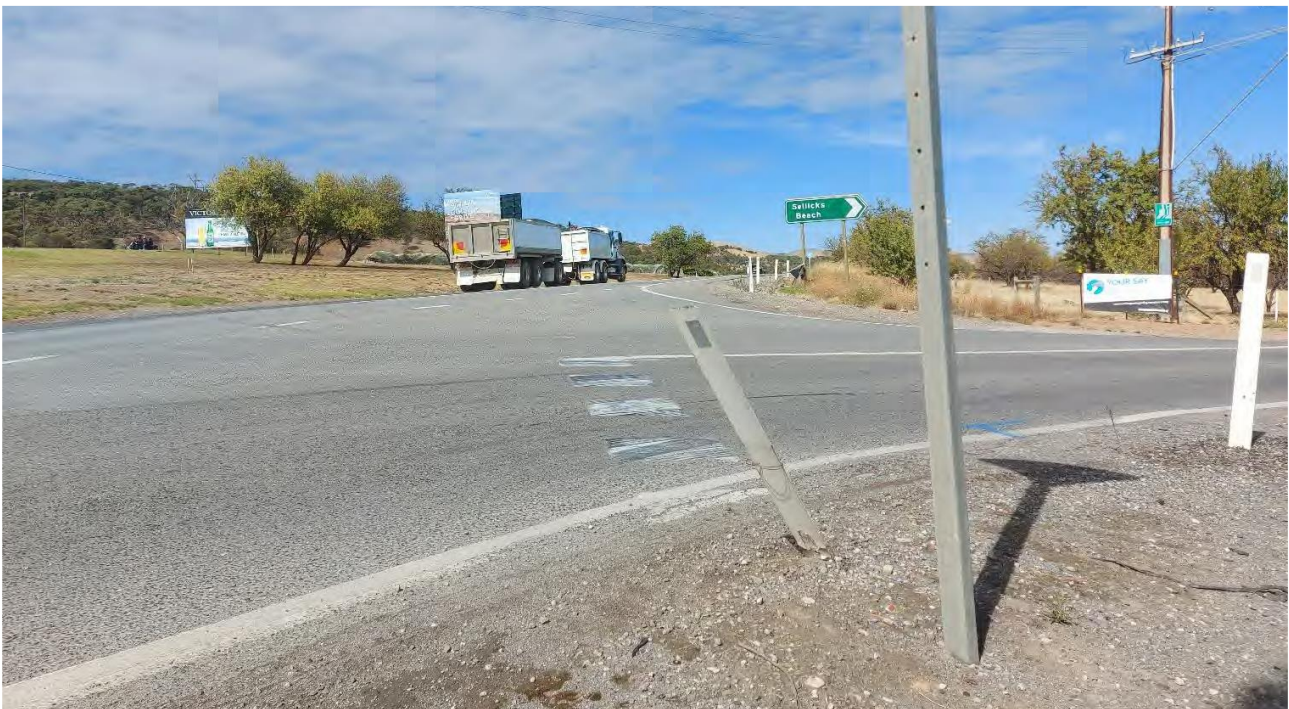
Figure 94: Poor sight distance when turning on to Main South Road from Sellicks Beach Road
