# Risky Roads 2021 survey results

Report – February 2022

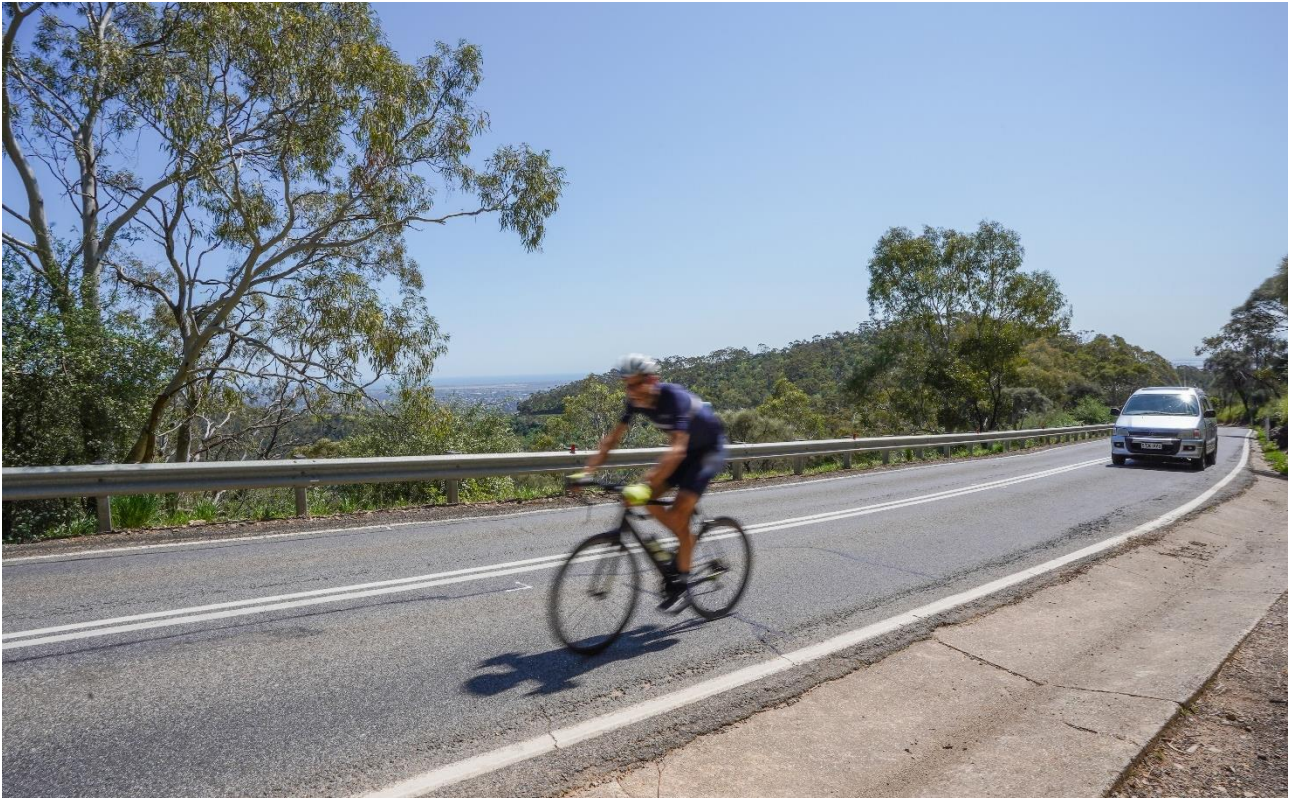
Most nominations for Greenhill Road were for the section between Burnside and Summertown and were largely about the roads narrow lanes and tight curves, as well as poor maintenance. The top five issues nominated on the road included:

Figure 27: Greenhill Road is a narrow corridor, and popular with cyclists

Greenhill Road in the Adelaide Hills is an inherently risky road, with tight curves, steep inclines, narrow lanes and steep drop-offs. Measurements taken during our 2020 Adelaide Hills Regional Road Assessment indicated lane widths of about 2.7m and a total seal width of 5.6m, including narrow shoulders. Whilst this geometry is far below the Austroads recommended minimum of 8.8m (3.3m lanes, 1.0m shoulders), providing an additional 3.2m of carriageway on Greenhill Road would come at immense cost, and would not be justifiable when weighed against other significant road upgrades that are needed across the state.

- A speed limit review between Burnside and Summertown, with consideration to adopting a 60km/h speed limit for this section, and
- A full road reseal between Burnside and Summertown.

Centre line audio tactile line marking was also recommended to deter road users from crossing the centreline. This treatment has been effective at reducing crashes on Gorge Road, which has comparable alignment to this part of Greenhill Road.

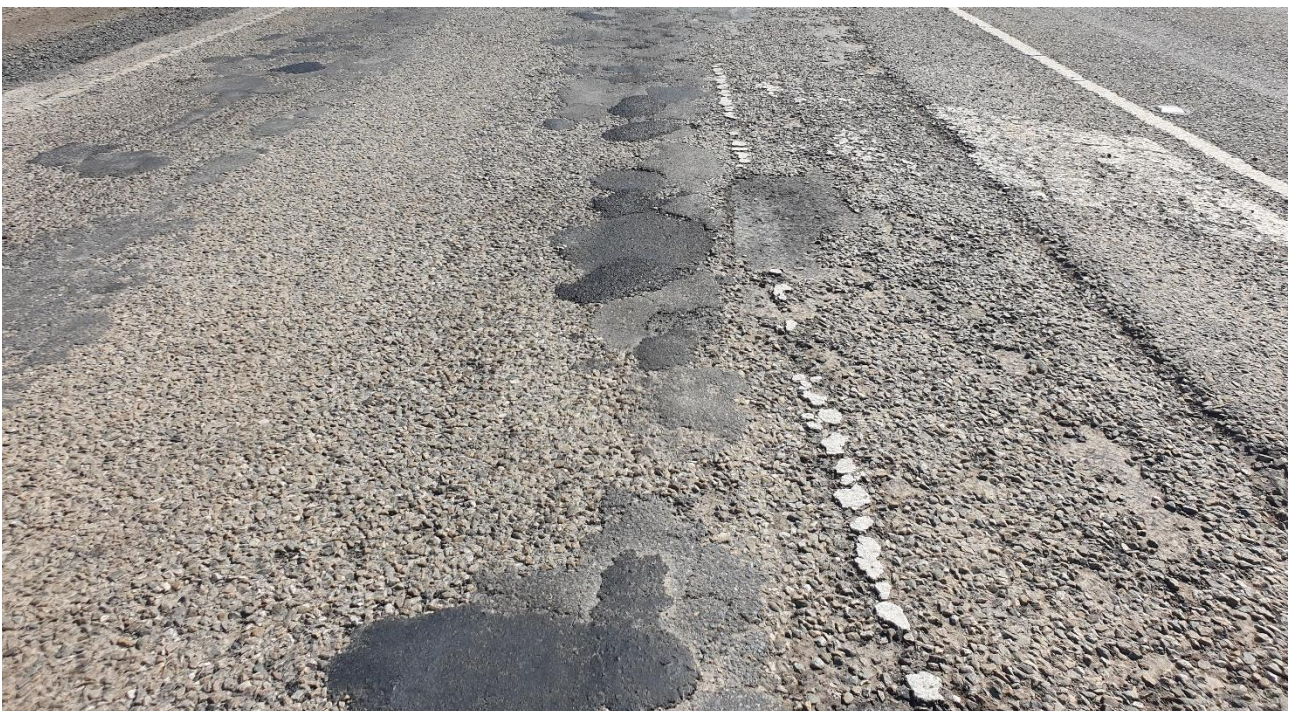
Figure 41: A section of Horrocks Highway between Rhynie and Tarlee assessed by RAA in September 2021

This feedback confirms the results of RAA’s September 2021 review of the highway, where it was identified that pavement rehabilitation and reconstruction was still required between Gawler and Rhynie, acknowledging the substantial improvements made between Clare and Wilmington. Upgrades between Clare and Wilmington have included shoulder sealing, pavement rehabilitation and barrier installation, which have all contributed to a higher AusRAP star rating being achieved along this part of the corridor. An example of this is shown in Table 24 below, where the AusRAP star rating on the pictured section increased from one to three stars.

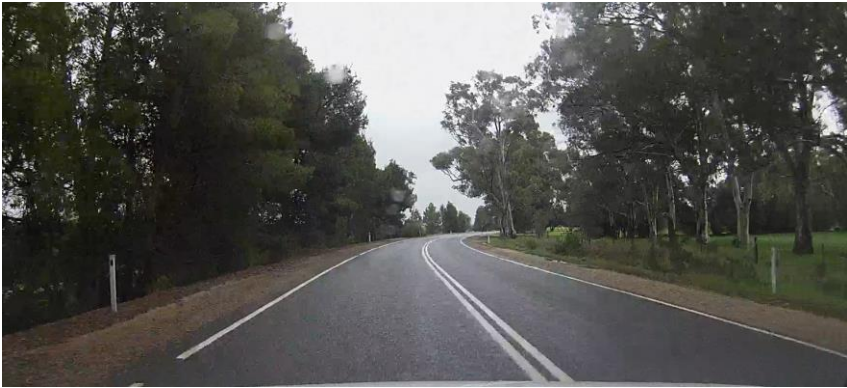
<p>★☆☆☆☆ (24.31)</p>	<p><u>Positives</u></p> <ul style="list-style-type: none"> <li>• Good pavement condition</li> <li>• Narrow sealed shoulders</li> <li>• Wide lanes</li> <li>• Good delineation</li> </ul> <p><u>Negatives</u></p> <ul style="list-style-type: none"> <li>• Moderate curve</li> <li>• Trees 1-5m from edge</li> <li>• 100km/h speed limit</li> </ul>
<p>After upgrade (footage from 2021 RAA review):</p>

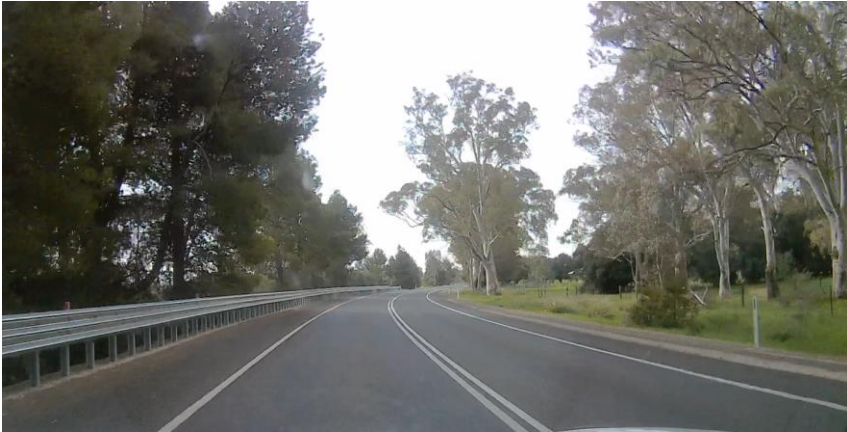
<p>★★★☆☆ (11.64)</p>	<p><u>Positives</u></p> <ul style="list-style-type: none"> <li>• Good pavement condition</li> <li>• Moderate width sealed shoulders</li> <li>• Wide lanes</li> <li>• Good delineation</li> <li>• Safety barrier reducing exposure to hazards</li> </ul> <p><u>Negatives</u></p> <ul style="list-style-type: none"> <li>• Moderate curve</li> <li>• Trees 5-10m from edge</li> <li>• 100km/h speed limit</li> </ul>

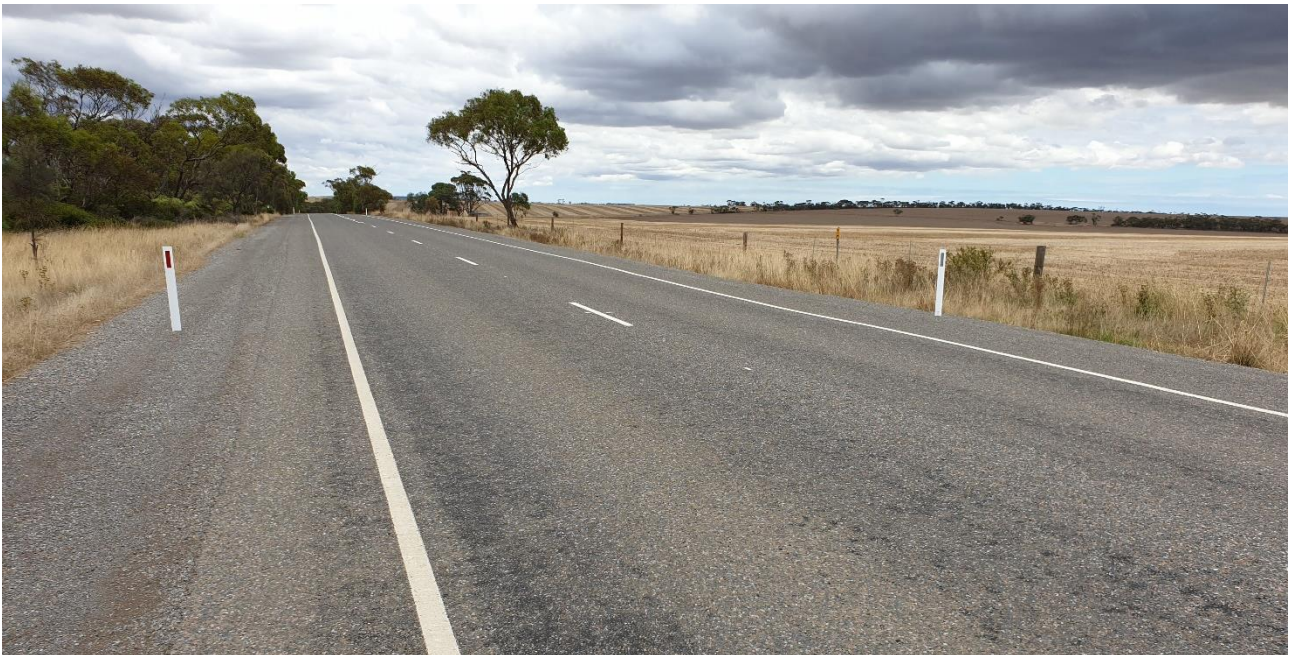
Figure 44: The section between Arthurton and Maitland is significantly safer following an upgrade in 2021

The 2021 upgrade between Arthurton and Maitland has improved the typical AusRAP star rating of this section from one star to three stars, which will substantially reduce the likelihood of serious and fatal crashes occurring.

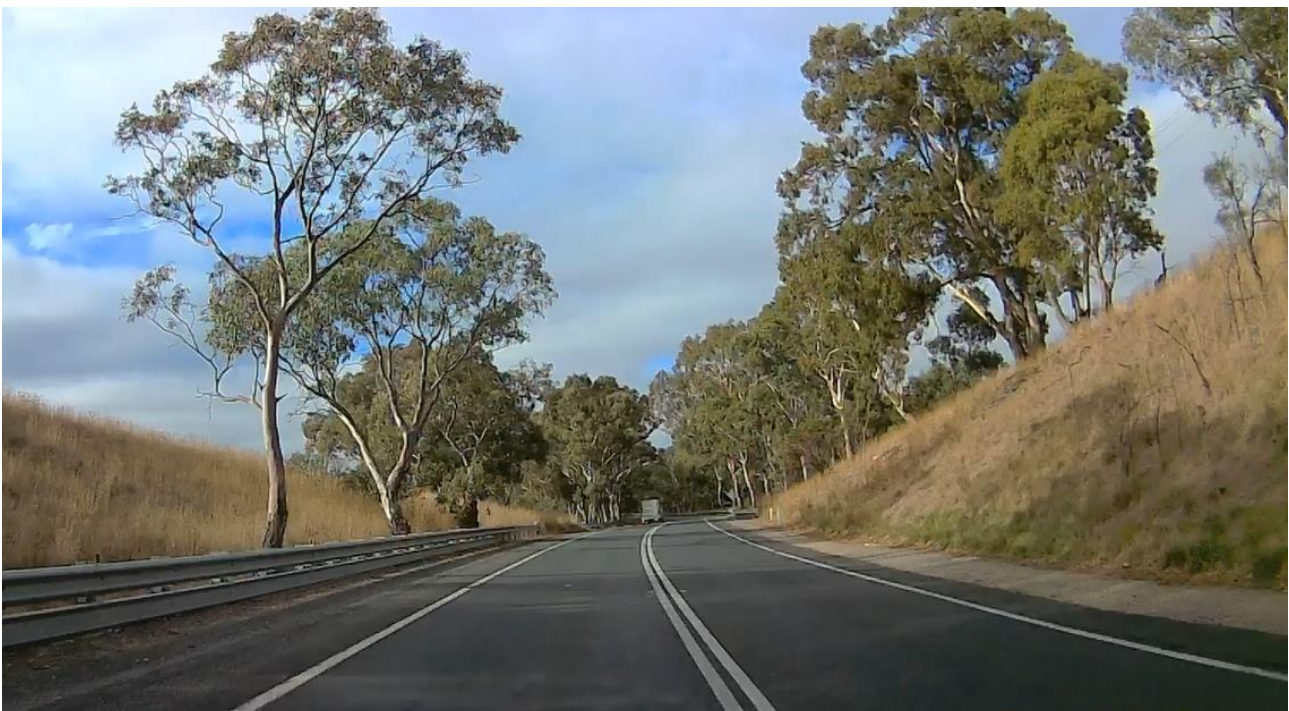
Figure 58: Overtaking opportunities are scarce on Long Valley Road due to curves and crests and high traffic volumes

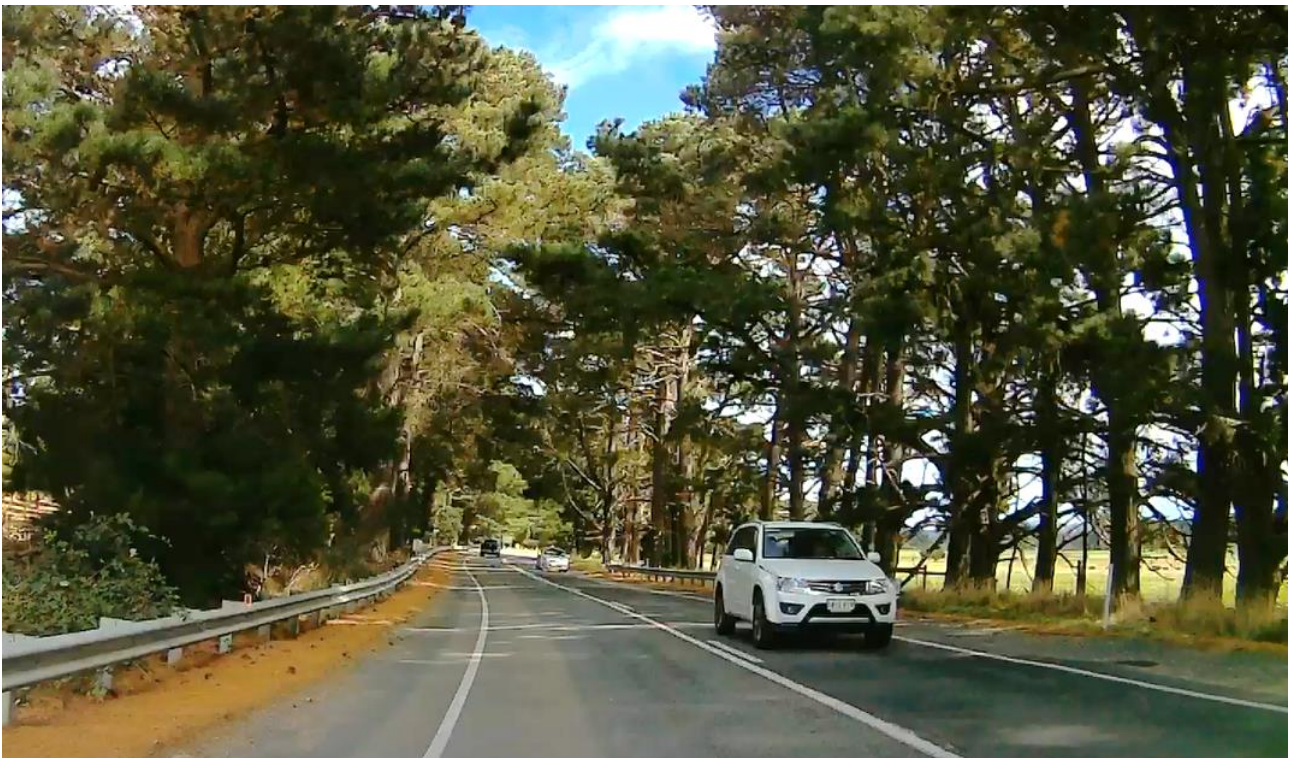
Figure 64: Goolwa Road is busy and overtaking opportunities are scarce

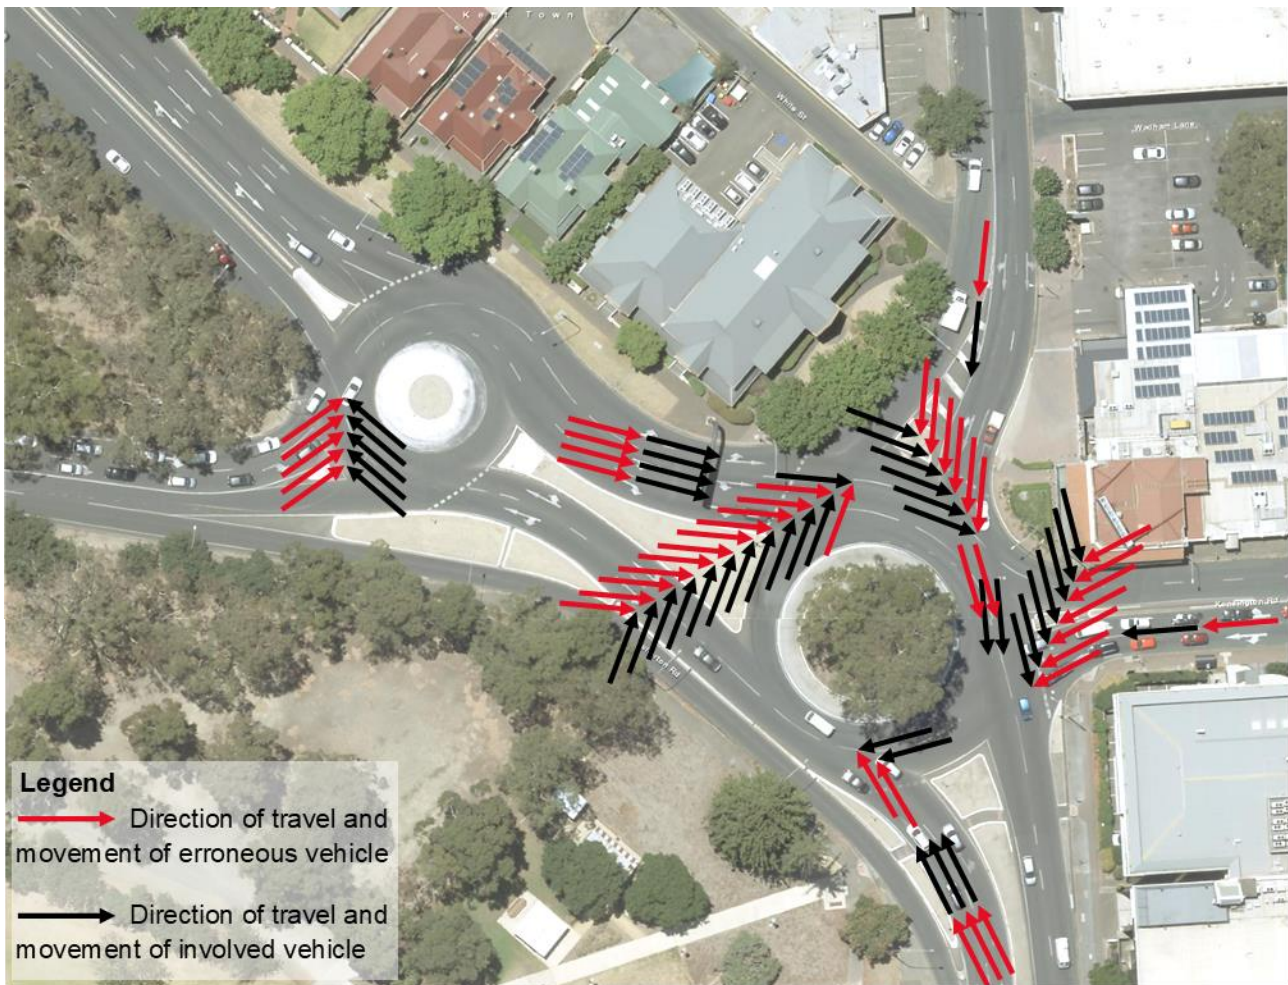
The crash diagram in Figure 72 shows the crash types and vehicle movements in these crashes between 2016 and 2020. The most common crash location was a right angle crash on the large roundabout, involving a vehicle approaching from the west and a vehicle about to exit the roundabout onto Fullarton Road and continue north. Twelve of these crashes occurred over the five year period, with eleven being attributed to the vehicle entering the roundabout. The next most common location, with seven crashes, was a right angle crash involving a vehicle approaching on Kensington Road and a vehicle travelling south through the roundabout about to exit onto Fullarton Road and continue south.

Figure 72: Diagram showing the crash types and directions at Britannia Roundabout between 2016 and 2020

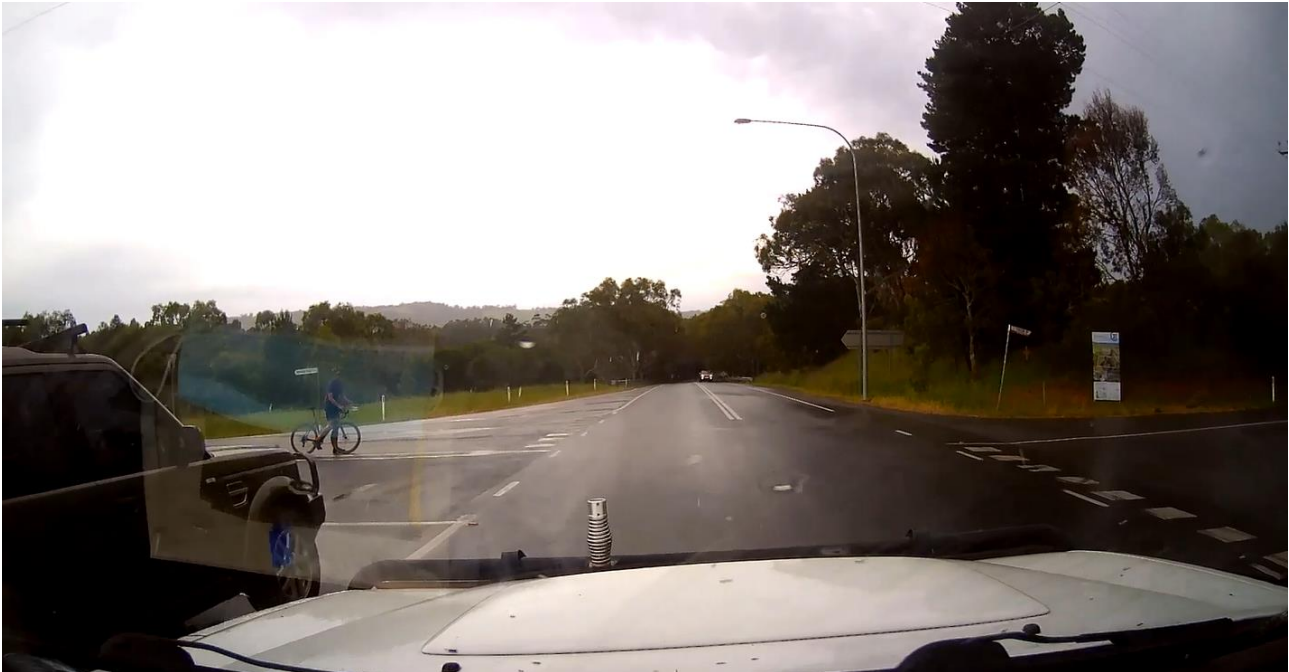
Figure 73: Dashcam footage at the intersection was provided by a survey respondent showing a very near miss between a vehicle performing an illegal overtaking manoeuvre and a cyclist on Hindmarsh Tiers Road

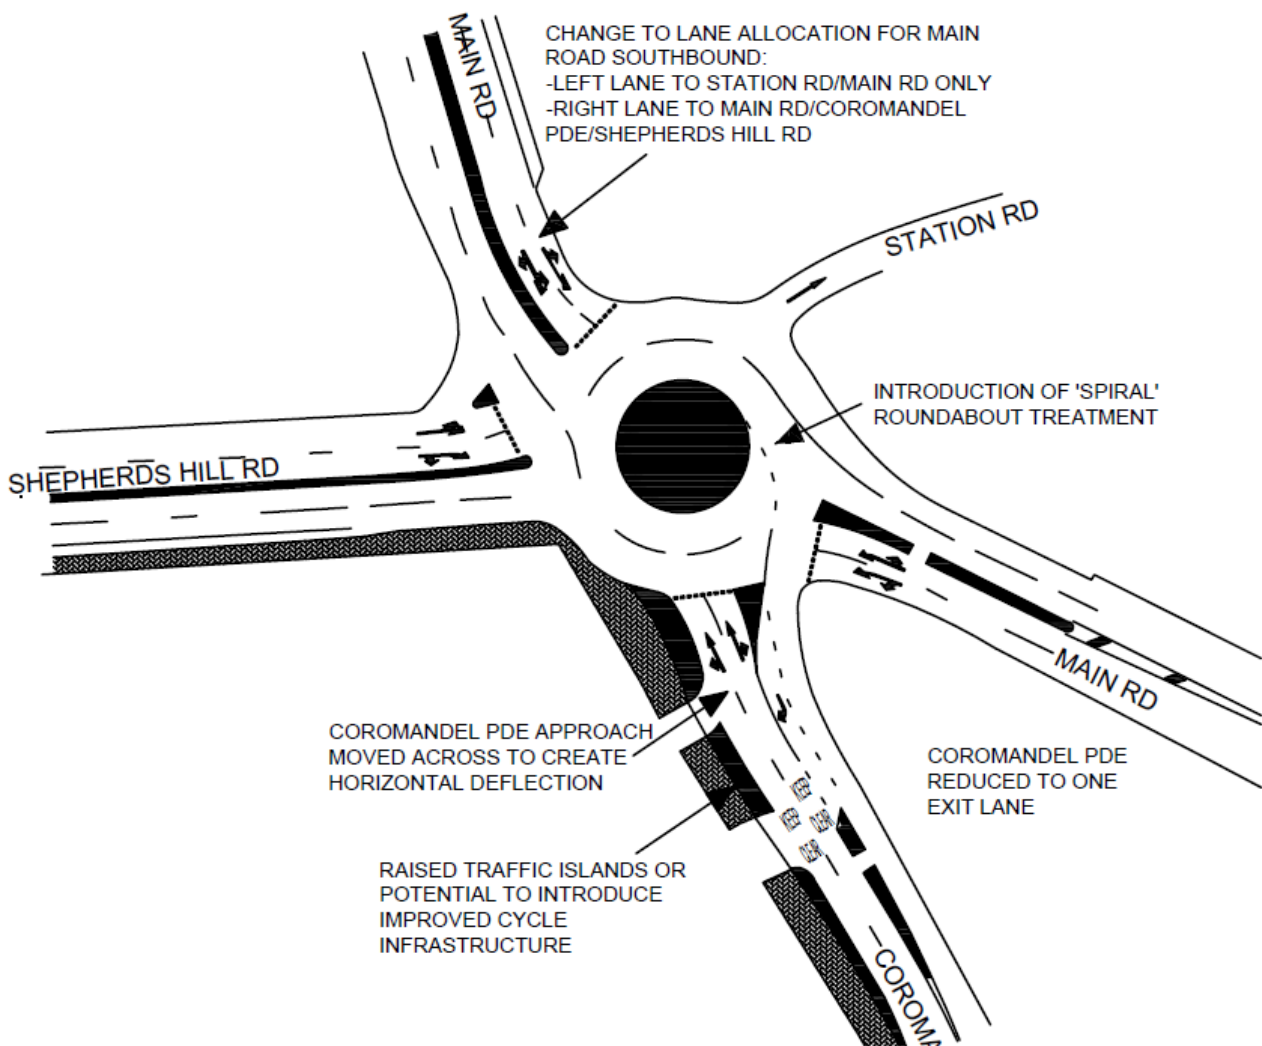
- The high approach speeds and lack of horizontal deflection for northbound traffic on Coromandel Parade, and
- Conflict between traffic in the right lane of Shepherds Hill Road travelling onto Main Road (south) and traffic in the left lane of Main Road (north) travelling onto Coromandel Parade.

Figure 82: Sketch of potential Blackwood Roundabout improvements

This design reduces the likelihood of conflict between traffic in the right lane of Shepherds Hill Road travelling onto Main Road (south) and traffic in the left lane of Main Road (north) travelling onto Coromandel Parade by removing the option of travelling from the left lane of Main Road (north) onto Coromandel Parade. However, this means that additional traffic would use the right lane of Main Road (north), and traffic modelling to determine the impacts on queueing and lane utilisation is required.

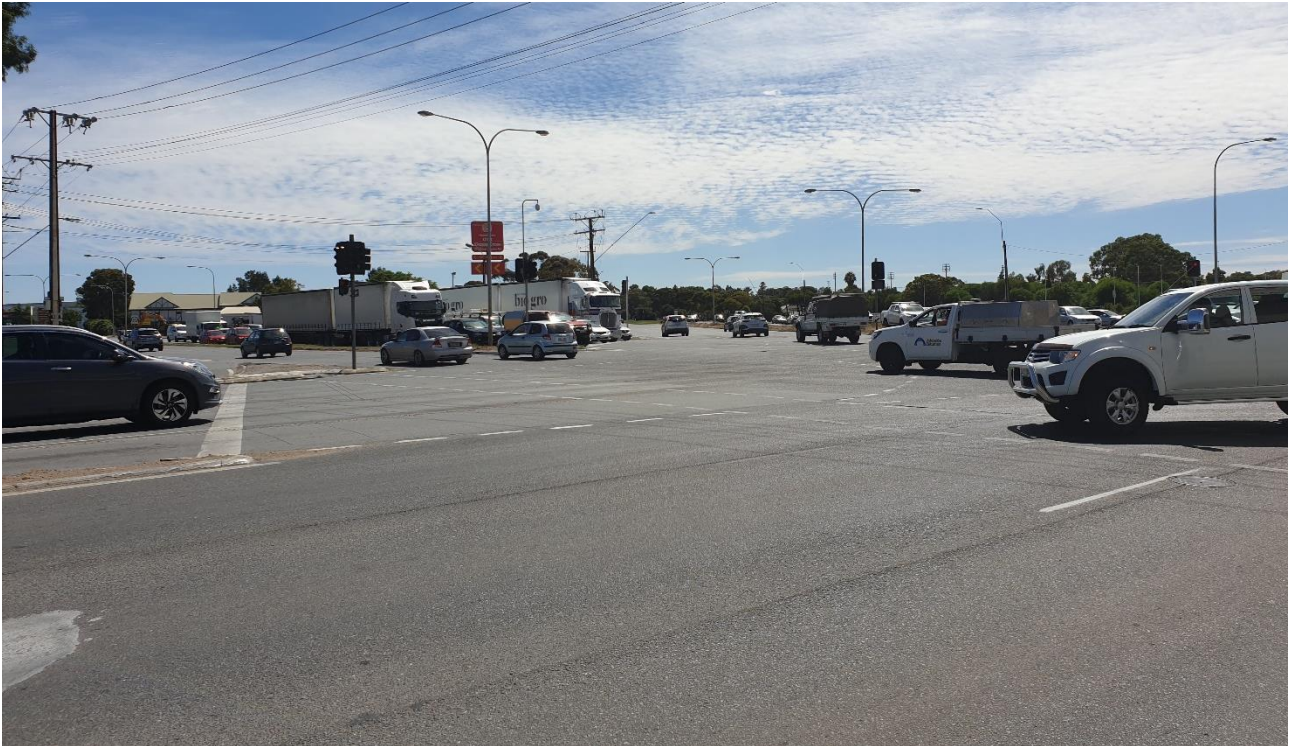
Four in five nominations for the intersection cited a poor or confusing intersection layout, while half indicated that there were inadequate crossing or turning opportunities at the intersection. The top 5 issues nominated at the intersection were:

Figure 84: The Gepps Cross five-way is wide and expansive to facilitate most turning movements

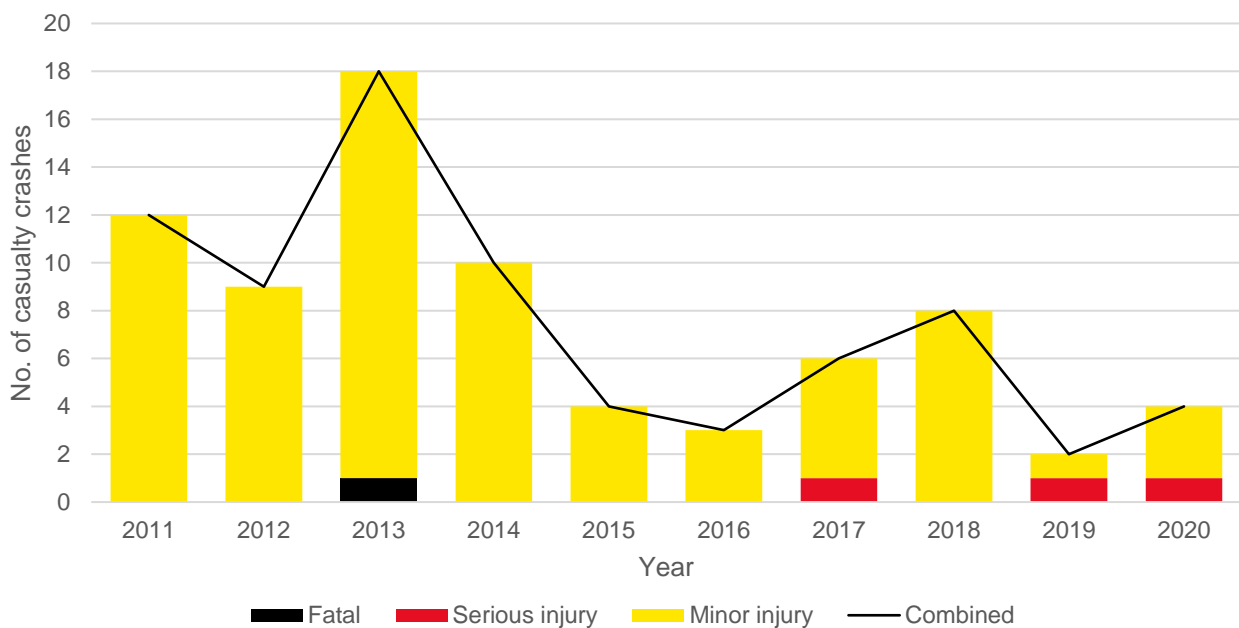
Casualty crashes at the intersection have tended to decline over the decade, with the annual average number of crashes more than twice as high for the 2011-2015 period (10.6 per year) compared to the 2016-2020 period (4.6 per year).

Figure 85: Ten year trend in casualty crashes at the Gepps Cross five-way

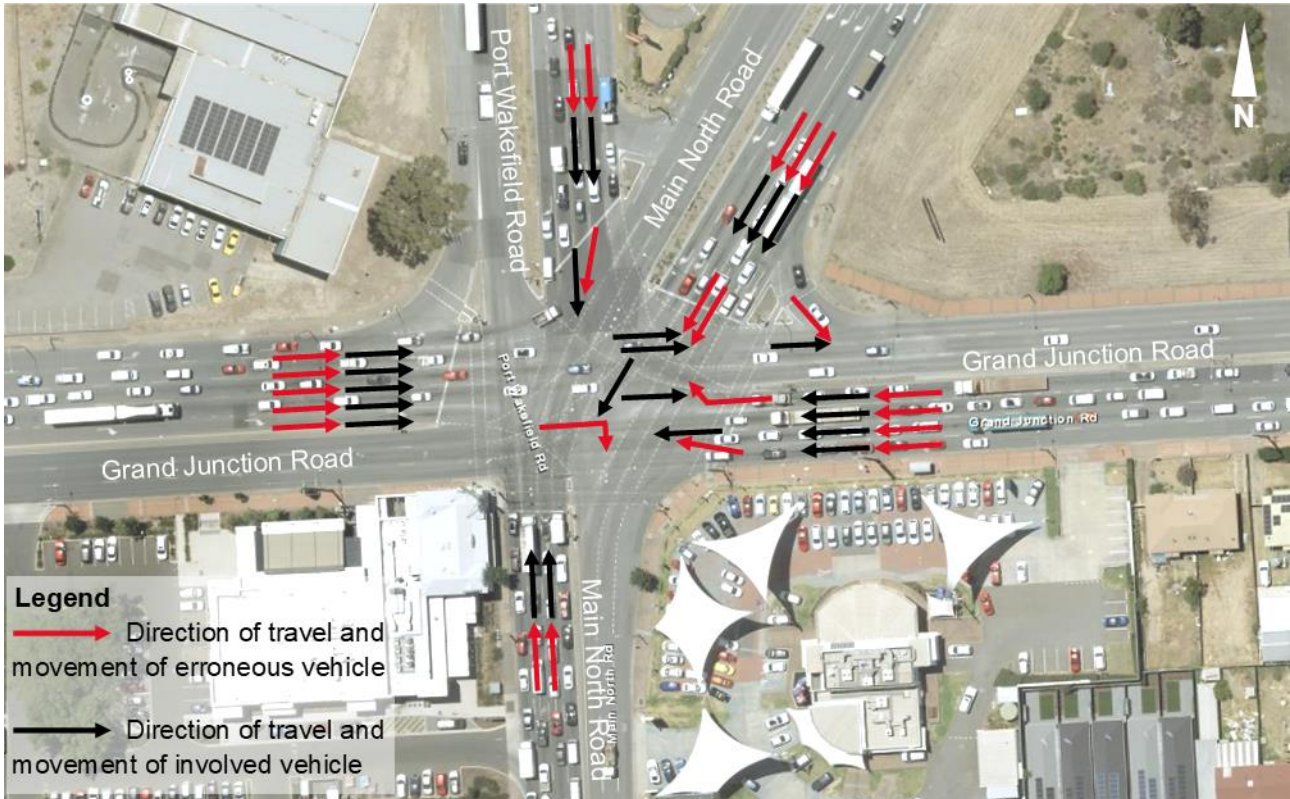
Rear end crashes most frequently occurred on the Grand Junction Road approaches to the intersection, with five in the eastbound direction and four in the westbound direction. There were no significant trends with turning or side swipe crashes, which occurred in a range of locations.

Figure 86: Diagram showing the crash types and directions at the Gepps Cross five-way between 2016 and 2020

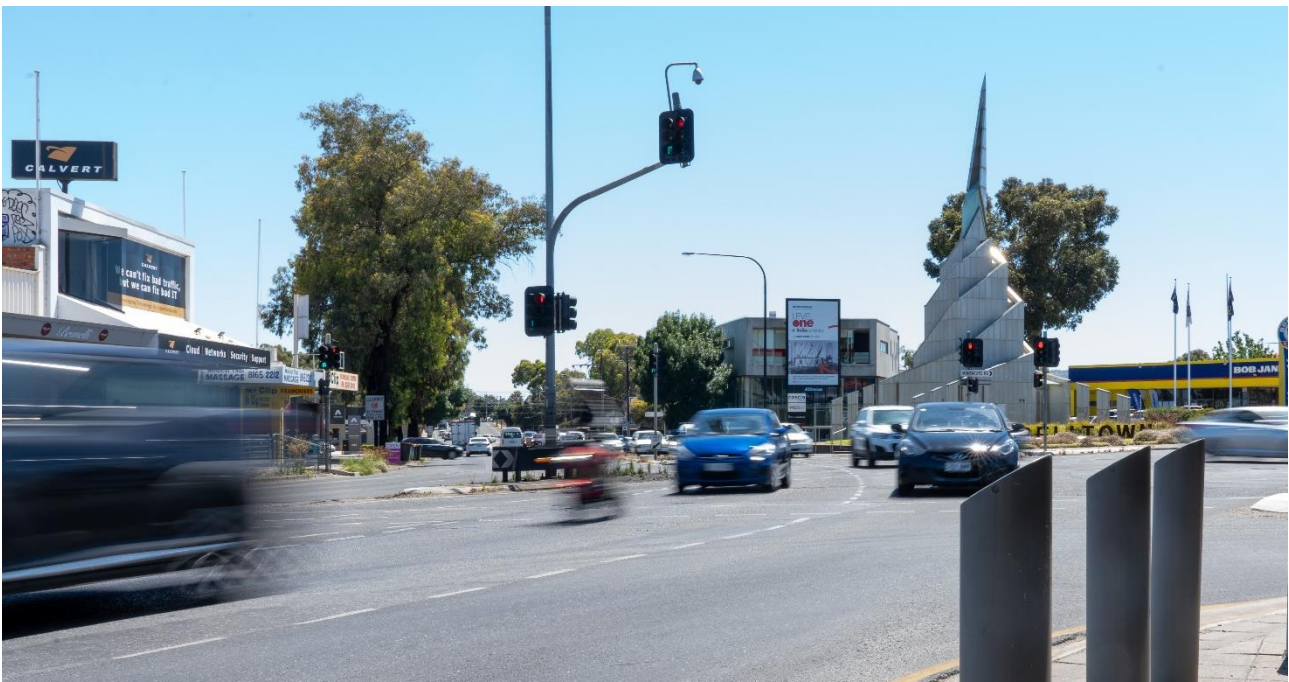
Figure 87: Glynde Corner is a busy intersection, and a notorious crash hotspot.

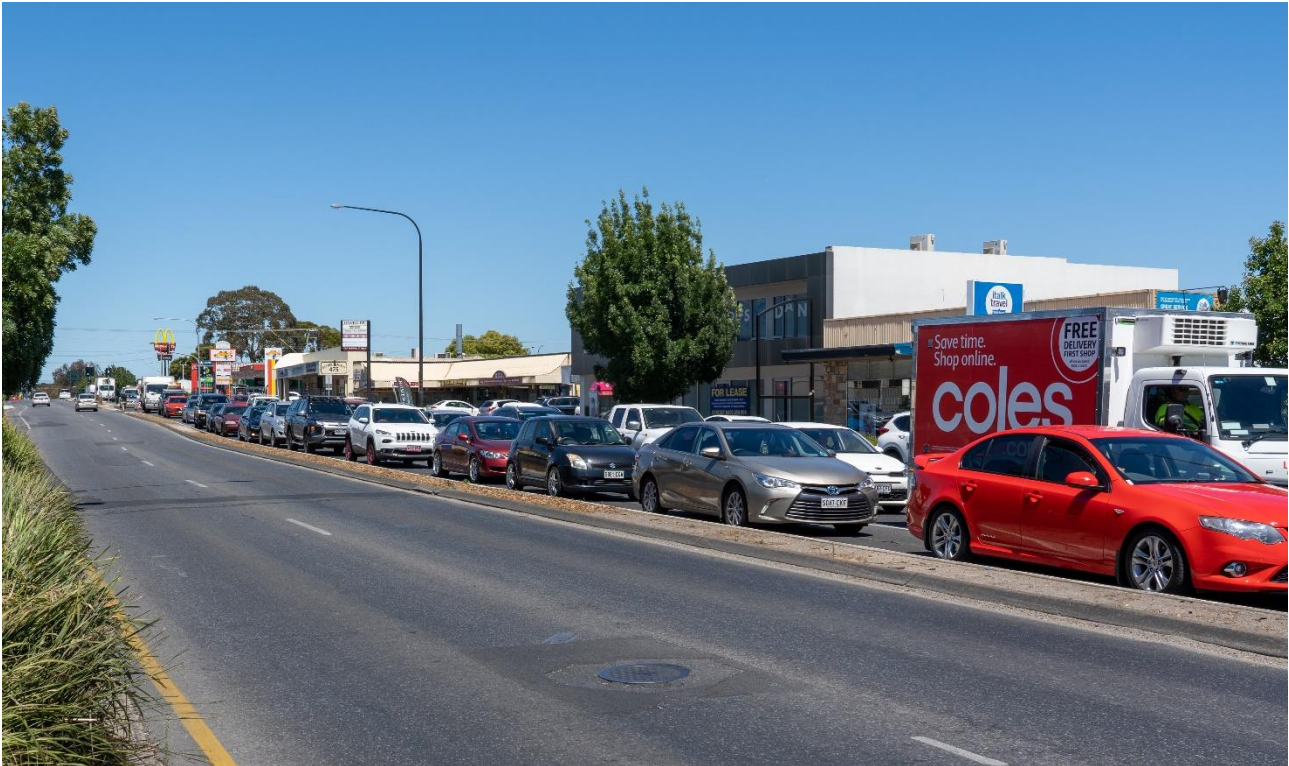
Figure 88: The volume of turning traffic on Payneham Road regularly surpasses the capacity of the right turn lanes. The number of casualty crashes occurring at the intersection has remained fairly steady over the past decade, with an average of 5.5 casualty crashes occurring every year.

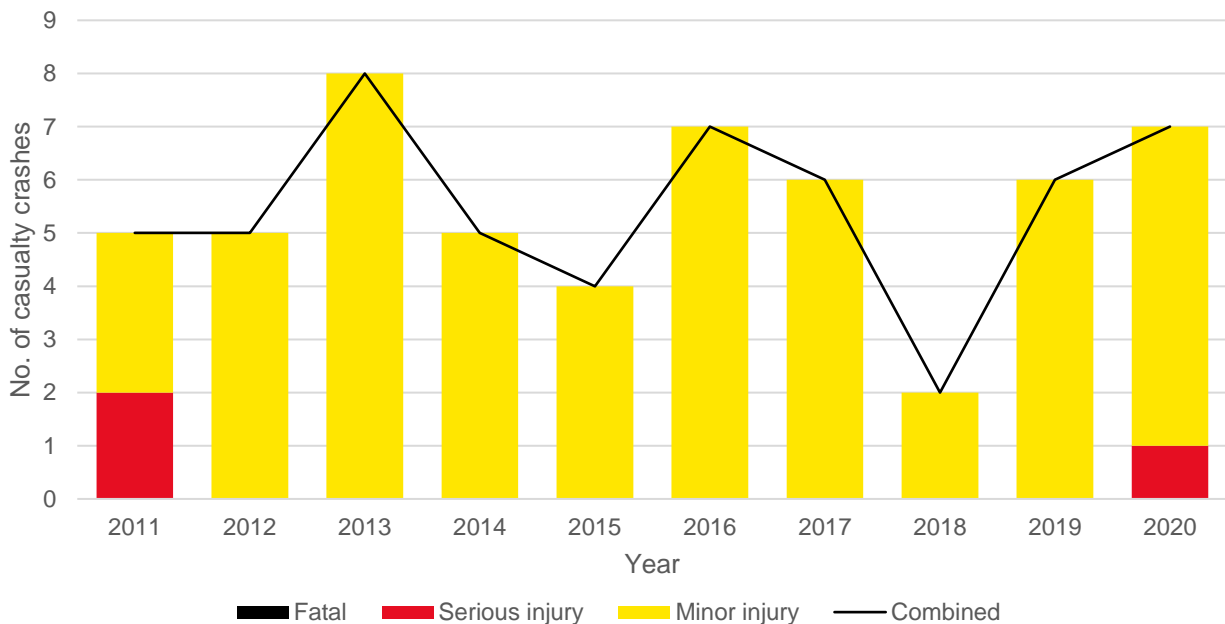
Figure 89: Ten year trend in casualty crashes at Glynde Corner

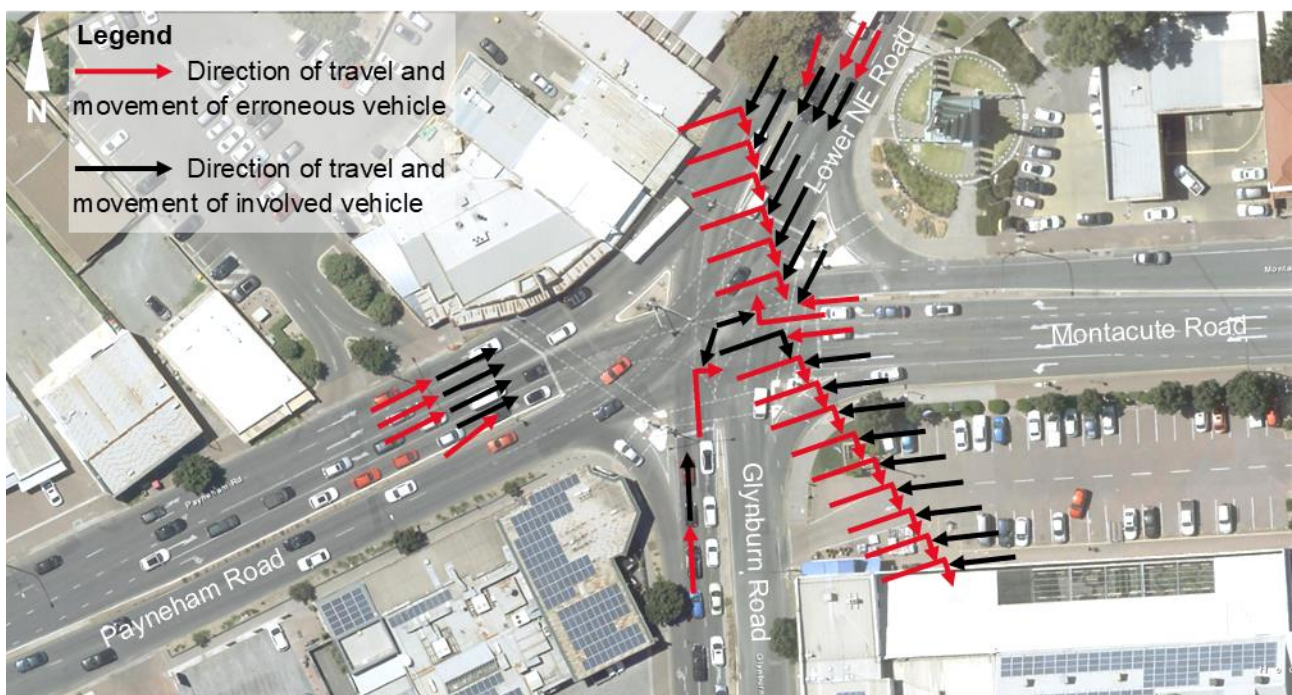
From the crash diagram in Figure 90, it is clear that the main crash issue at the intersection involves vehicles turning right from Payneham Road. In particular, there were 10 casualty crashes involving a vehicle turning right onto Glynburn Road and a vehicle travelling straight from Montacute Road onto Payneham Road. The vehicle turning right was deemed responsible in nine of these crashes.

Also of concern are six right turn crashes involving a vehicle turning right from Payneham Road and a vehicle continuing straight ahead on Lower North East Road. The available crash data does not have enough information to determine whether Payneham Road traffic was turning onto Montacute Road or Glynburn Road, or whether Lower North East Road traffic was turning onto Glynburn Road or Payneham Road, however, based on a review of signal phasing, it is considered more likely that they involve traffic turning from Payneham Road onto Montacute Road.

Figure 90: Diagram showing the crash types and directions at Glynde Corner

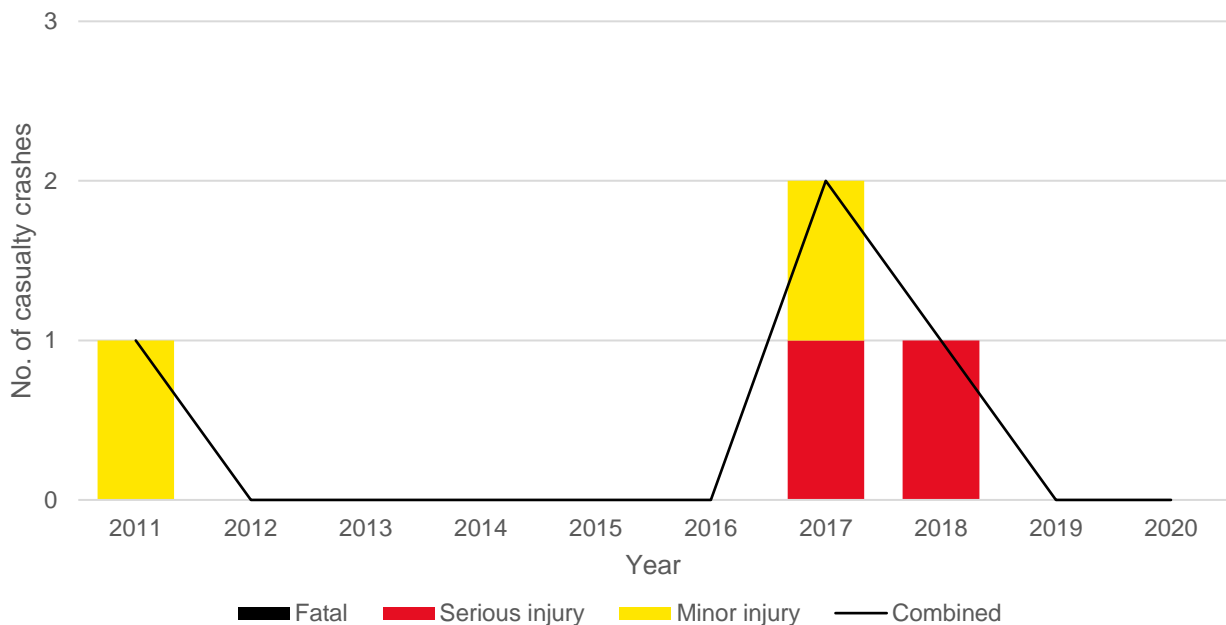
Four casualty crashes occurred at the intersection over the past decade, with three occurring in the most recent five-year period. The RJAWS was installed in late 2018, after three casualty crashes occurred in the 18 months prior, including two resulting in serious injuries. RAA are not aware of any casualty crashes occurring since installation.

Figure 92: Ten year trend in casualty crashes at the Bull Creek Road/Paris Creek Road intersection

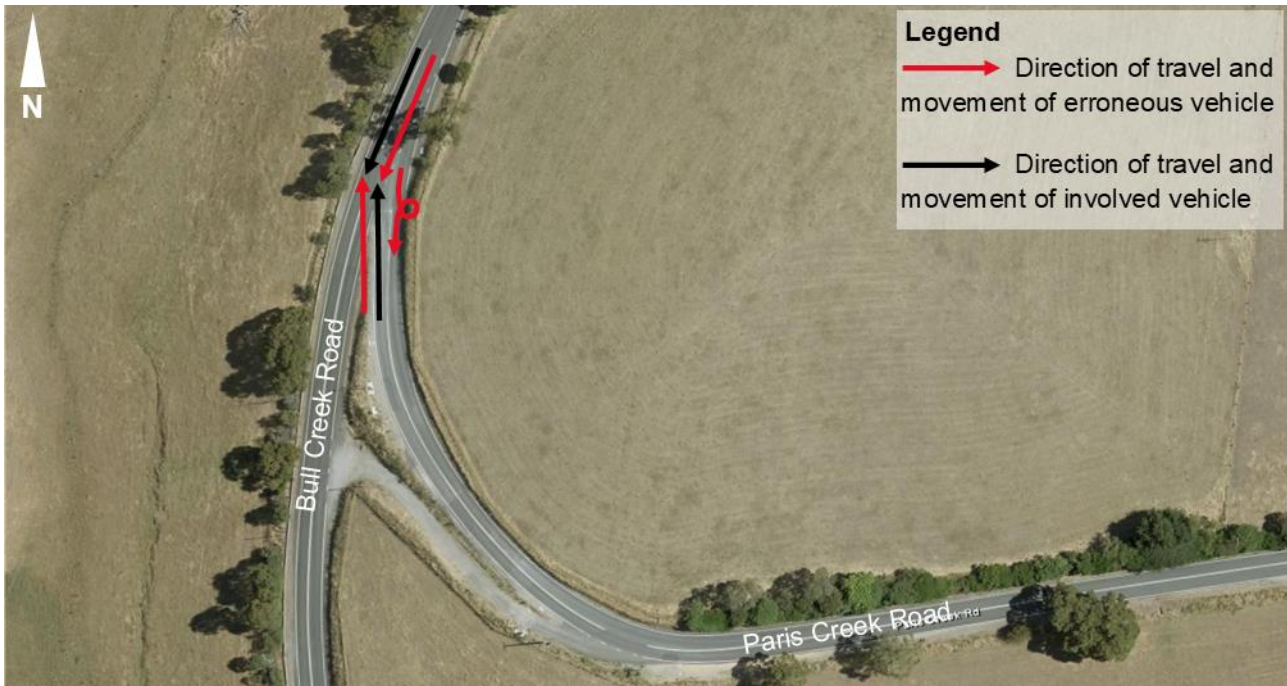
Whilst all three crashes at the intersection between 2016 and 2020 were in different circumstances, each involved a southbound vehicle on Bull Creek Road and can potentially be linked to poor visibility to the approaching intersection when travelling south.

- One was a right angle collision between a southbound motorcycle, and a vehicle turning right from Paris Creek Road.
- One was a right angle collision between a vehicle turning left onto Paris Creek Road and a vehicle stopped on the carriageway of Paris Creek Road to turn right.
- One was a rollover, involving a southbound vehicle turning left onto Paris Creek Road.

Figure 93: Diagram showing the crash types and directions at the Bull Creek Road/Paris Creek Road intersection between 2016 and 2020

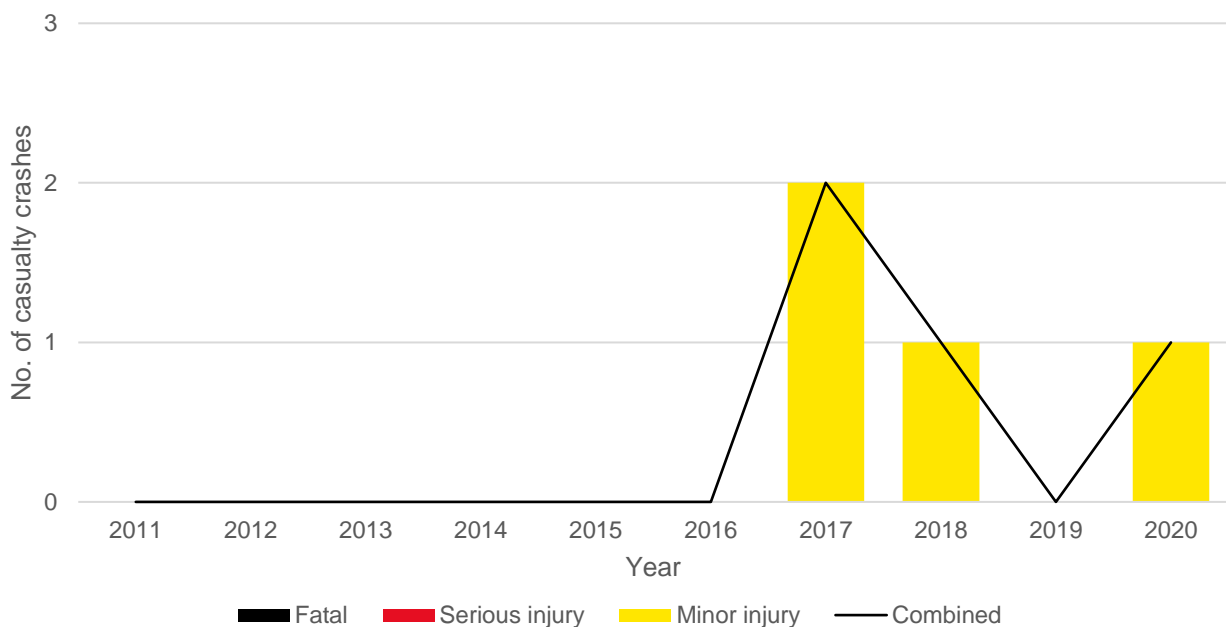
Whilst casualty crash numbers are low, all four casualty crashes over the past decade occurred between 2017 and 2020, indicating a potential upwards trend.

Figure 95: Ten year trend in casualty crashes at the Main South Road/Sellicks Beach Road intersection

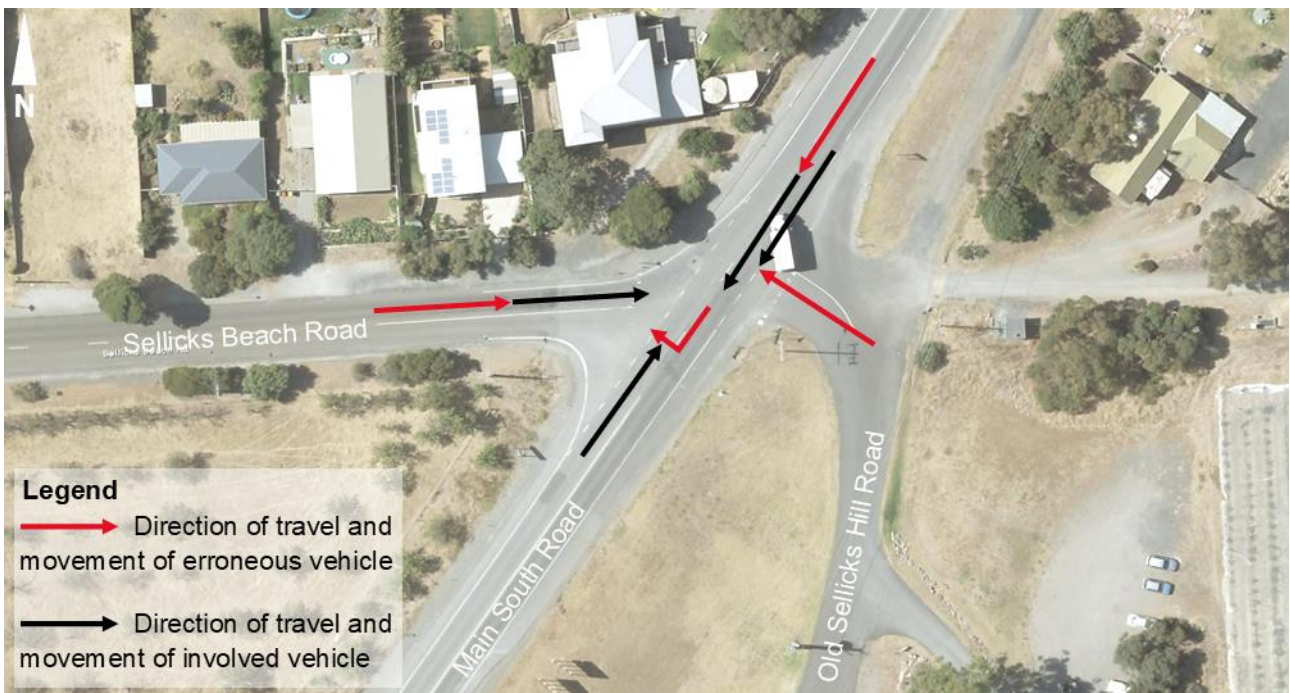
There are no strong trends with the four crashes, which are all in different locations at the intersection.

Figure 96: Diagram showing the crash types and directions at the Main South Road/Sellicks Beach Road intersection between 2016 and 2020

RAA is not aware of any planned upgrades at the intersection, however, the intersection is the end point of the second stage of the Main South Road upgrade between Seaford and Sellicks Beach. RAA considers it likely that this project will include a safety upgrade at the intersection and have raised this during submissions to the Main South Road upgrade project team.
